Preliminary Report

Accident on **24 March 2015**
at **Prads-Haute-Bléone**
(Alpes-de-Haute-Provence, France)
to the **Airbus A320-211**
registered **D-AIPX**
operated by **Germanwings**

Controlled descent on autopilot, collision with terrain

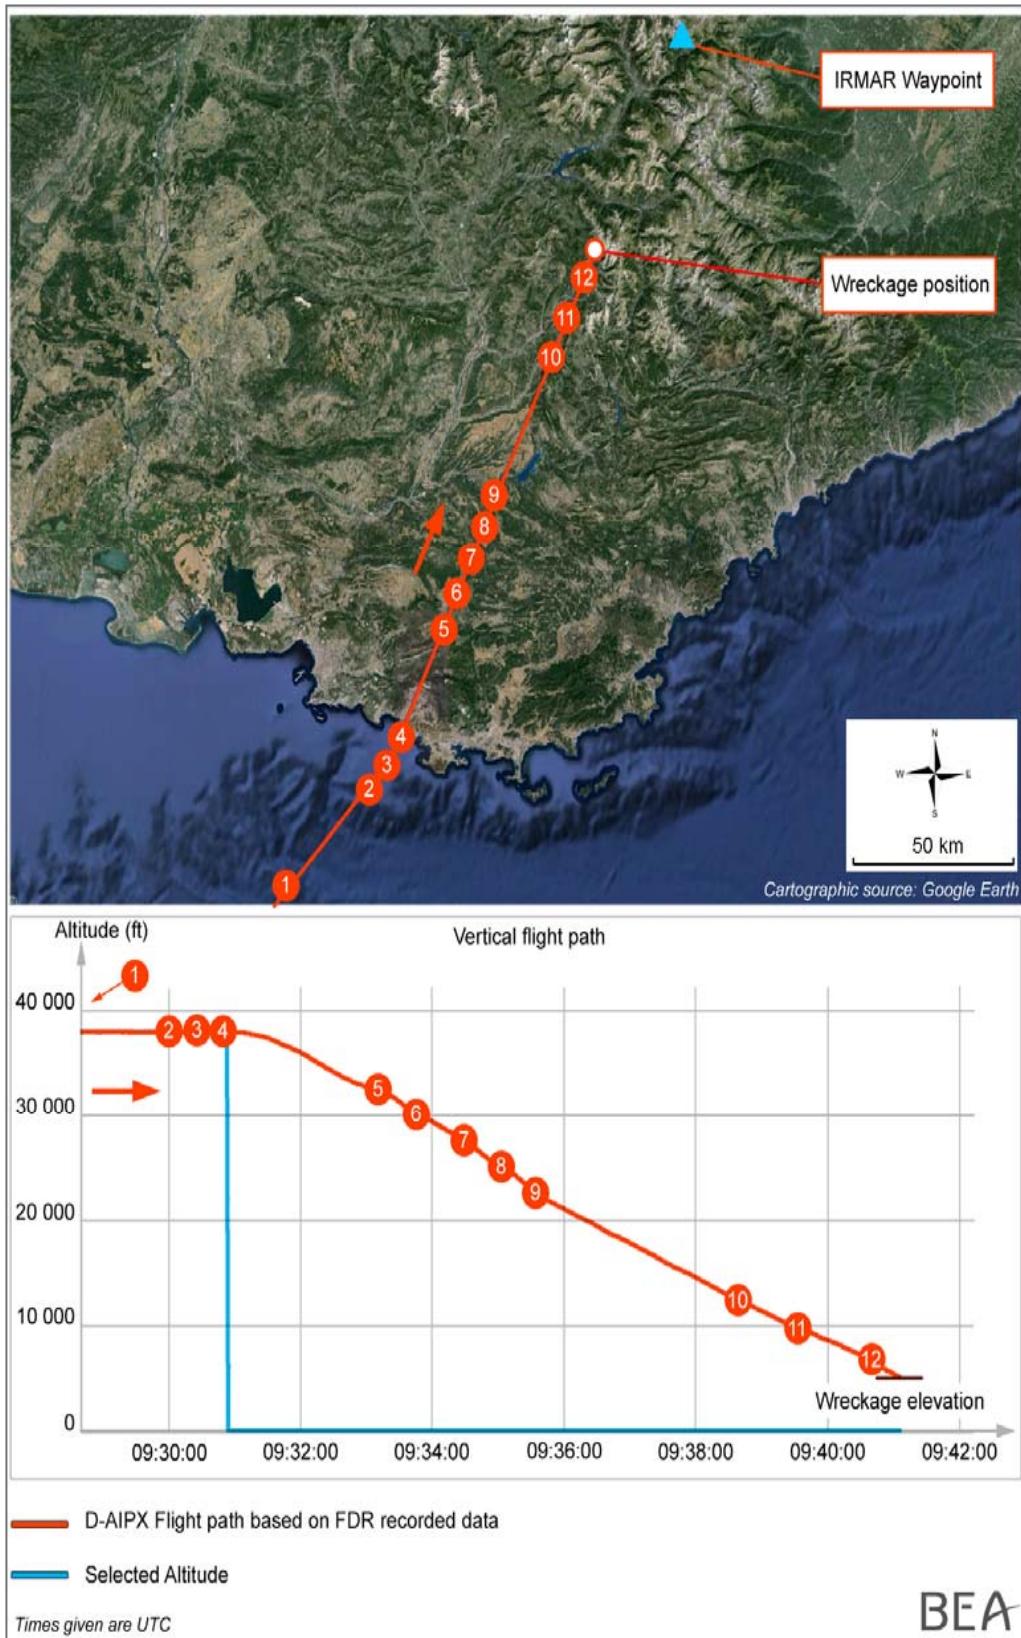
Figure 1 – accident flight trajectory

Note: the following elements are based on the flight recorders, as well as on recordings of radio communications. The main points in the history of the flight below are referenced by the numbers on figure 1, page 10.

At 9 h 30 min 00 (point ②), the Captain read back the controller's clearance allowing him to fly direct to the IRMAR point: "*Direct IRMAR Merci Germanwings one eight Golf*". This was the last communication between the flight crew and ATC.

At 9 h 30 min 24 (point ③), noises of the opening then, three seconds later, the closing of the cockpit door were recorded. The Captain was then out of the cockpit.

At 9 h 30 min 53 (point ④), the selected altitude on the FCU changed in one second from 38,000 ft to 100 ft⁽²⁾. One second later, the autopilot changed to "OPEN DES"⁽³⁾ mode and autothrust changed to "THR IDLE" mode. The aeroplane started to descend and both engines' rpm decreased.

At 9 h 33 min 12 (point ⑤), the speed management changed from "managed" mode to "selected"⁽⁴⁾ mode. A second later, the selected target speed became 308 kt while the aeroplane's speed was 273 kt. The aeroplane's speed started to increase along with the aeroplane's descent rate, which subsequently varied between 1,700 ft/min and 5,000 ft/min, then was on average about 3,500 ft/min.

At 9 h 33 min 47 (point ⑥), the controller asked the flight crew what cruise level they were cleared for. The aeroplane was then at an altitude of 30,000 ft in descent. There was no answer from the co-pilot. Over the following 30 seconds, the controller tried to contact the flight crew again on two occasions, without any answer.

At 9 h 34 min 31 (point ⑦), the buzzer to request access to the cockpit was recorded for one second.

At 9 h 35 min 03 (point ⑧), the selected speed increased again to 350 kt⁽⁵⁾.

At 9 h 40 min 41 (point 12), the "Terrain, Terrain, Pull Up, Pull Up" aural warning from the GPWS triggered and remained active until the end of the flight.

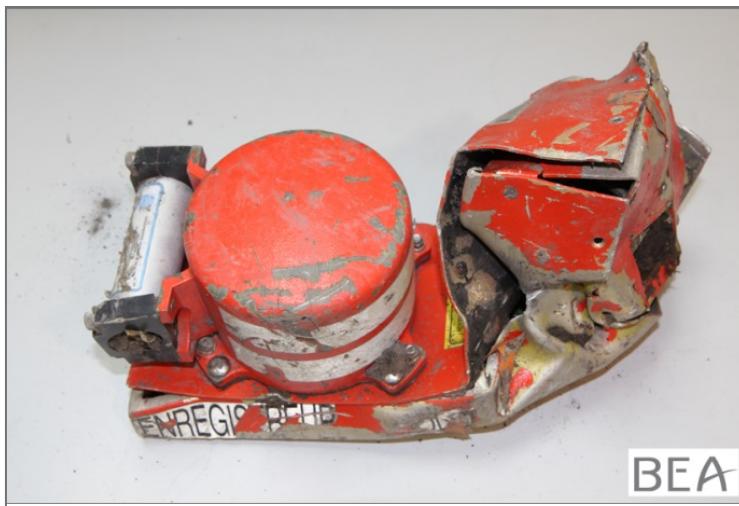
Figure 9 - cockpit voice recorder (CVR) – D-AIPX

The CVR was sent to the BEA on 25 March 2015 under judicial seal.

Given the significant damage to the CVR, the memory card was extracted from the protected module, visually inspected and tested electrically. Reading the data on the manufacturer's official equipment made it possible to obtain six audio tracks:

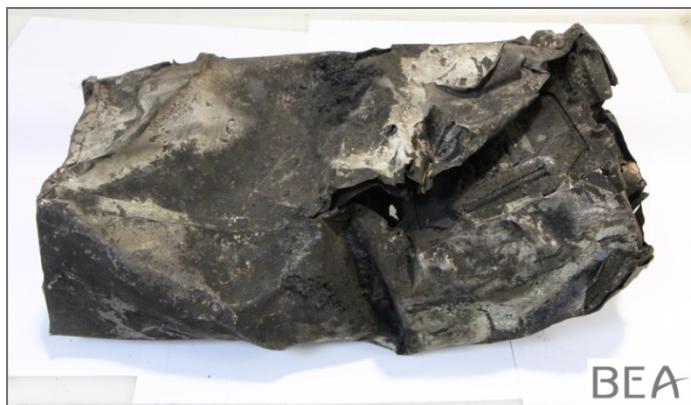
Figure 10 - Flight data recorder (FDR) - D-AIPX

The FDR was sent to the BEA on 2 April 2015 under judicial seal.

It showed significant mechanical and thermal damage. All of the equipment was covered in soot. After removing the protected module from the recorder casing, the memory card was removed from the protected module.

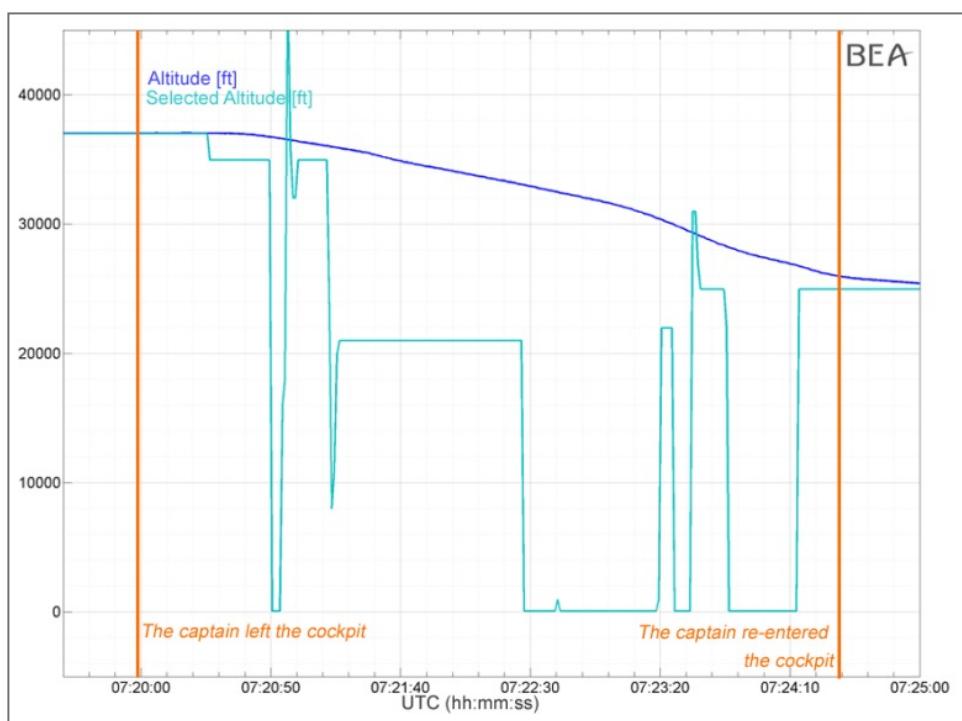
Figure 11 - descent during the previous flight

- at 7 h 20 min 50, the selected altitude decreased to 100 ft for three seconds and then increased to the maximum value of 49,000 ft and stabilized again at 35,000 ft;
- at 7 h 21 min 10, the Bordeaux control centre gave the crew the instruction to continue the descent to flight level FL210;
- at 7 h 21 min 16, the selected altitude was 21,000 ft;
- from 7 h 22 min 27, the selected altitude was 100 feet most of the time and changed several times until it stabilized at 25,000 ft at 7 h 24 min 13;
- at 7 h 24 min 15, the buzzer to request access to the cockpit was recorded;
- at 7 h 24 min 29 noises like those of the unlocking of the cockpit door then its opening was recorded and corresponded to the Captain's return to the cockpit.

The following graphs were extracted from the FDR and illustrate the variations in selected altitude.

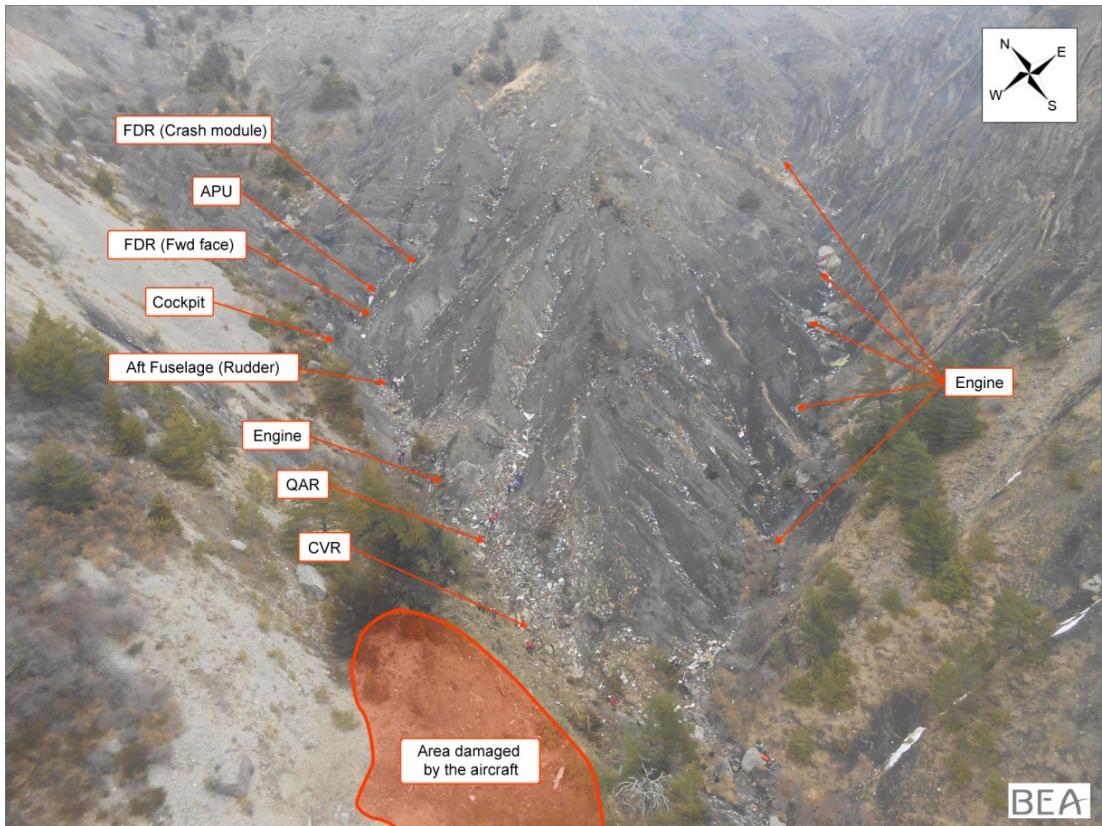
Figure 12 – general view of the accident site

On site, elements belonging to various parts of the aeroplane were identified. One of the engines was broken into many pieces in the main ravine. The debris of the other engine, concentrated in a small area, was found in the main west ravine.

The auxiliary power unit (APU) was located in the upper part of the site dozens of metres from the part of the rear fuselage to which the vertical stabilizer is attached. One of main landing gears was found near this part of the fuselage.

Parts from the cockpit (access door to the cockpit, sidestick, security camera) were also found in the upper part of the site.

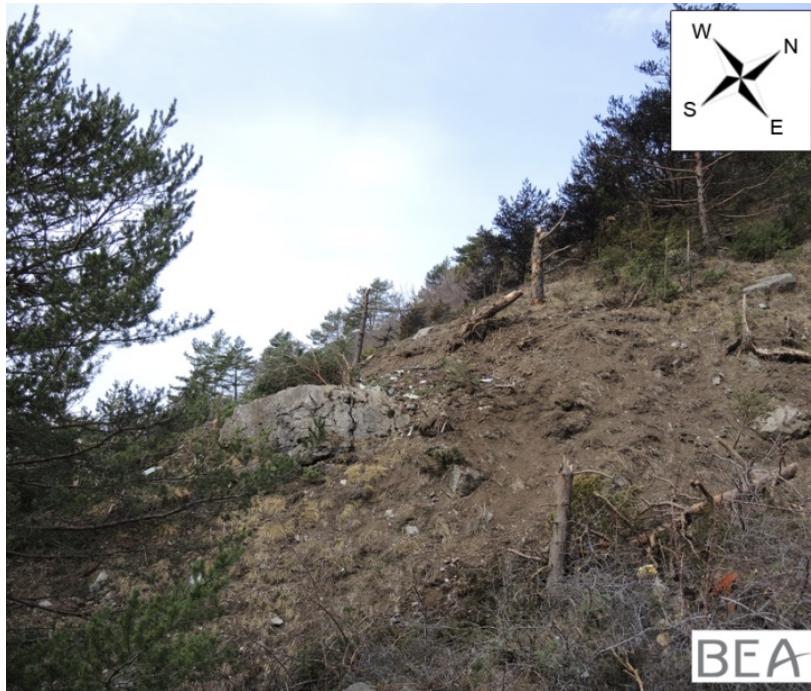
Figure 13 - contact area with vegetation

On the lower part of the site, about 20 m above the ravine, is an area where the vegetation had been torn up, tree trunks were uprooted, tree branches were broken and the ground churned up. Parts from the aeroplane's wings and fuselage were found in this area. Apart from this area and the final debris field, no other contact with the environment was observed around the accident site.
