**UNITED STATES AIR FORCE**  
**AIRCRAFT ACCIDENT INVESTIGATION**  
**BOARD REPORT**

**F-16CM, T/N 88-0510**

**31ST FIGHTER WING  
AVIANO AIR BASE, ITALY**

**DATE OF ACCIDENT: 28 JANUARY 2013**

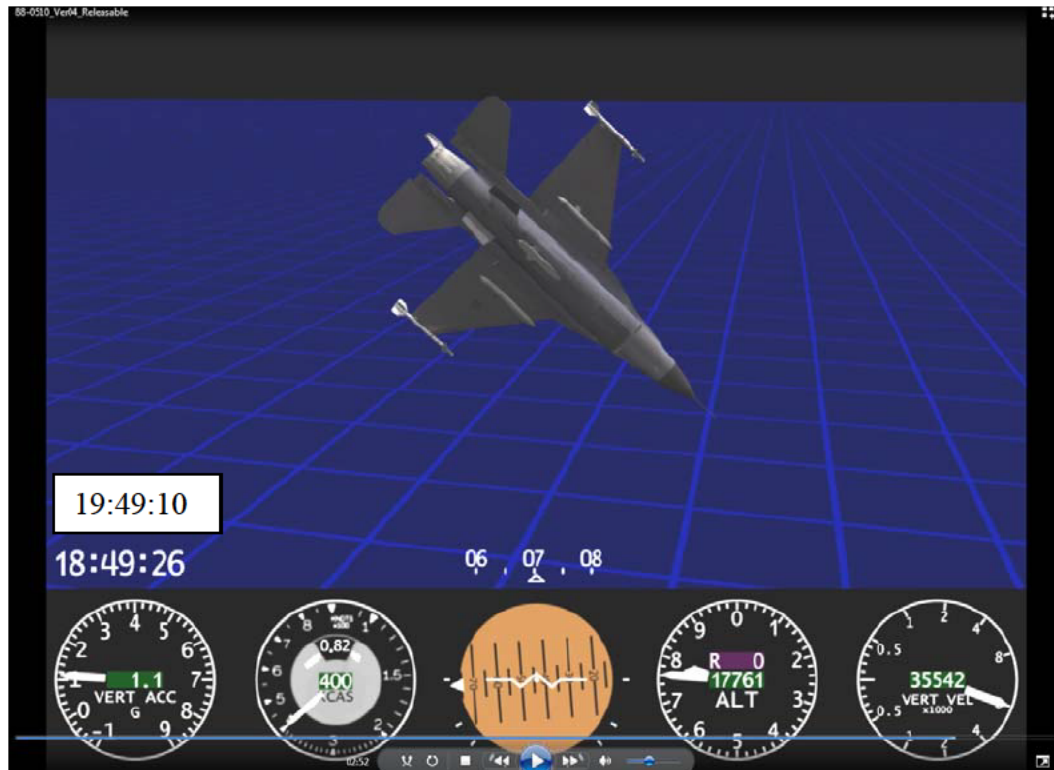
**Figure 1 (Tab Z-4)**

“Knock it off” procedures are used to direct aircraft or aircrew to stop engagements, scenarios and tactical maneuvering. “I’m spatial D” meant that the MP recognized that he was spatially disoriented. Spatial disorientation is a failure to correctly sense a position, motion, or attitude of the aircraft or of oneself within the fixed coordinate system provided by the surface of the earth and the gravitational vertical (Tab BB-32). Three seconds later at 19:49:16L, the MW directed the MP to transition to primary recovery instruments by communicating “Look at the round dials, disregard the HUD” (Tab N-17). The round dials are the primary attitude, altitude, and airspeed indicators used in unusual attitude recovery, and the HUD is the head-up display (Figure 2 and Tab BB-55).

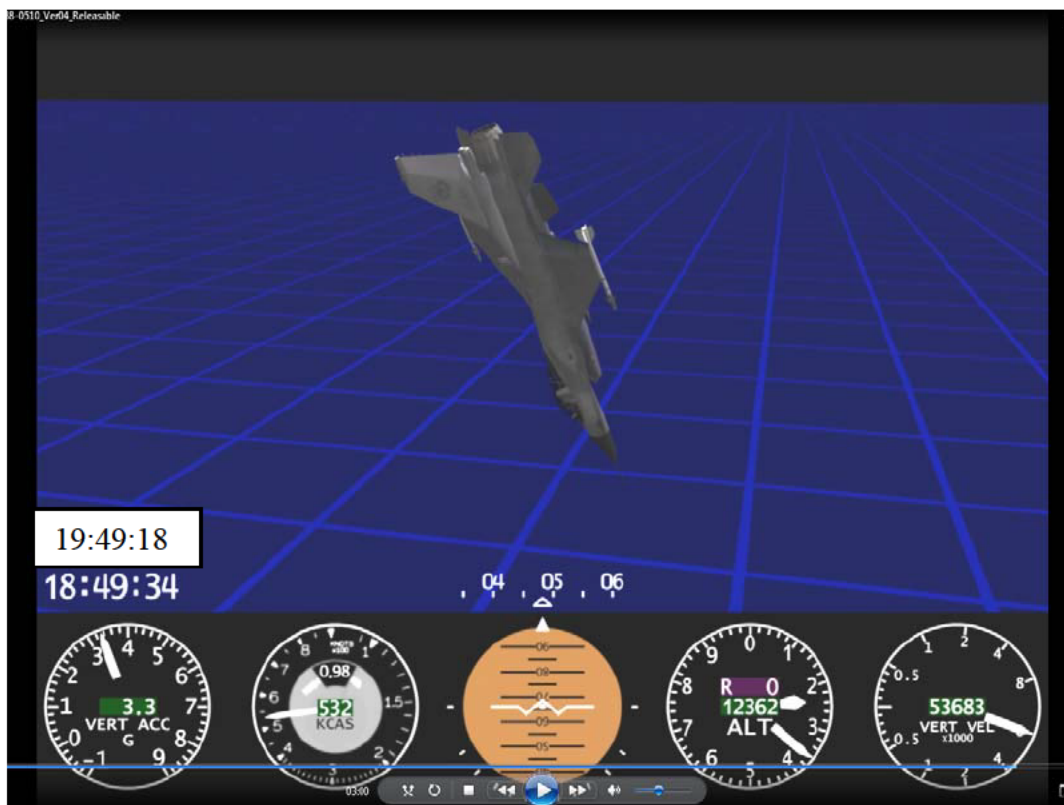
**Figure 3 (Tab Z-5)**

The MA initially continued with the same flight parameters. Then one second later, at 19:49:17L, the MP rolled the MA left, away from the horizon to approximately 180 degrees fully inverted, with the top of the canopy pointing directly towards the ground, and pulled to 70 degrees nose low, towards the water. The MA airspeed increased to 535 knots, as the MA passed through 12,000 feet of altitude. One second later, at 19:49:18L (Figure 3), the MP initiated a rapid roll to the right, attempting to establish wings level flight.

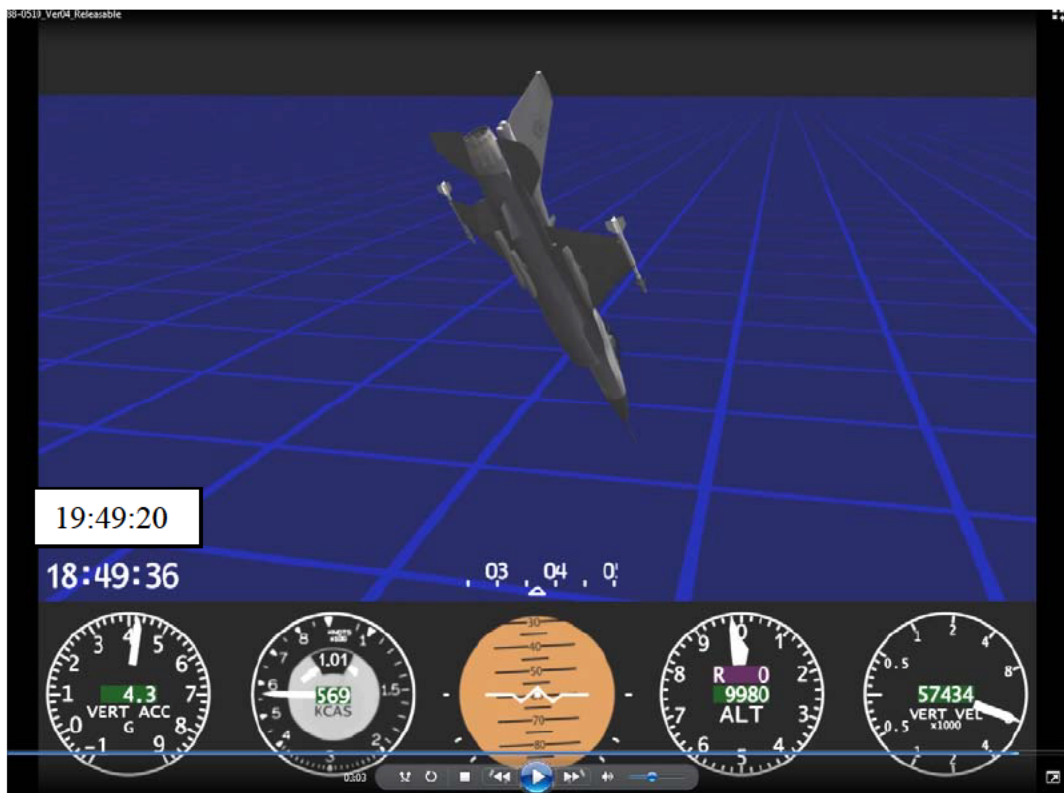
**Figure 4 (Tab Z-5)**

By 19:49:20L (Figure 4), at 10,000 feet, with a descent rate of 57,500 feet per minute, the MP established the MA at 55 degrees nose low in approximately upright wings level flight. At the same time, the MA's gravitational force loading increased from 2.0 Gs to a maximum recorded 8.6 Gs as the MA nose started to come up towards the horizon from 55 degrees nose low (Tab DD-9).

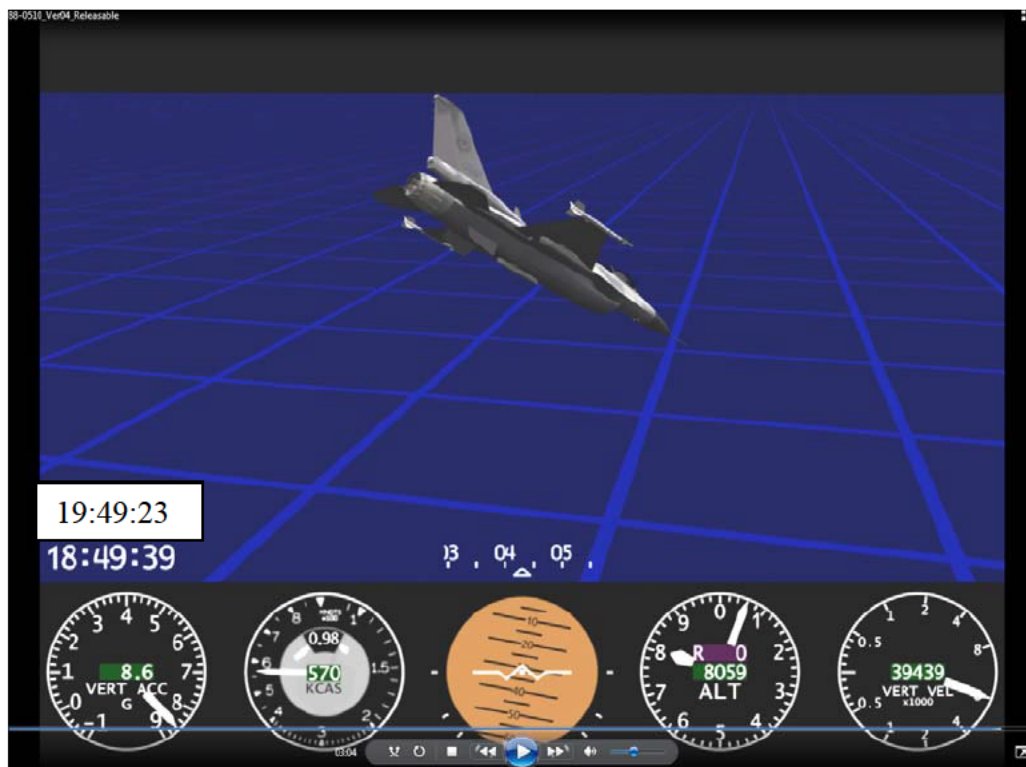
Figure 5 (Tab Z-6)

At 19:49:23L (Figure 5), the MW queried the MP: “1 status your round dials?” with no response from the MP (Tab N-17). This question implies the MW was trying to determine if the MP had transitioned his scan to the primary attitude instrument. At this time, the MA was at 25 degrees nose low, 15 degrees left bank, 568 knots, 8.6 Gs, while passing through 7,900 feet with a descent rate of 37,300 feet per minute (Tab DD-9).

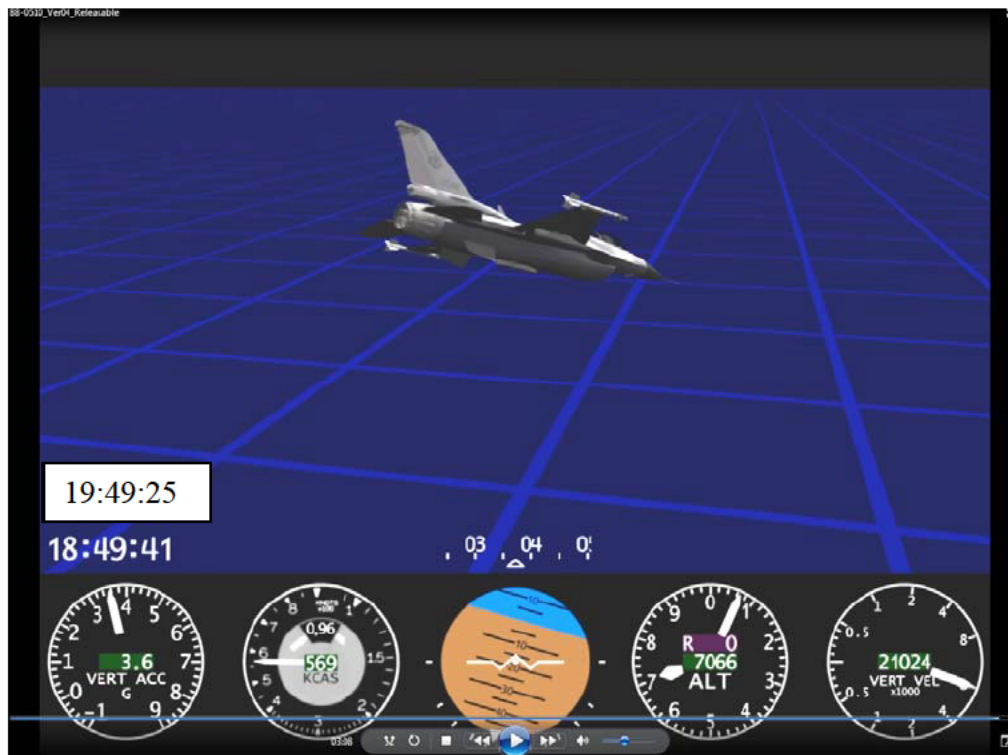
**Figure 6 (Tab Z-6)**

At 19:49:24L, the G forces on the MA started to decrease rapidly, indicating the MP was no longer pulling back on the control stick. The MP then initiated the ejection sequence. At 19:49:25L (Figure 6), the seat data recorder stopped receiving input from the MA, indicating the seat had begun to depart the MA.

The MA parameters at the time of the ejection were a heading of 037 degrees, 7,066 feet altitude, 569 knots (.96 Mach), dive angle of 16 degrees nose low, and 18 degrees left bank and with a 21,024 feet per minute rate of descent (Tab DD-9). The ejection occurred at approximately N 44 17.786 E 12 35.239 (Tab S-2).

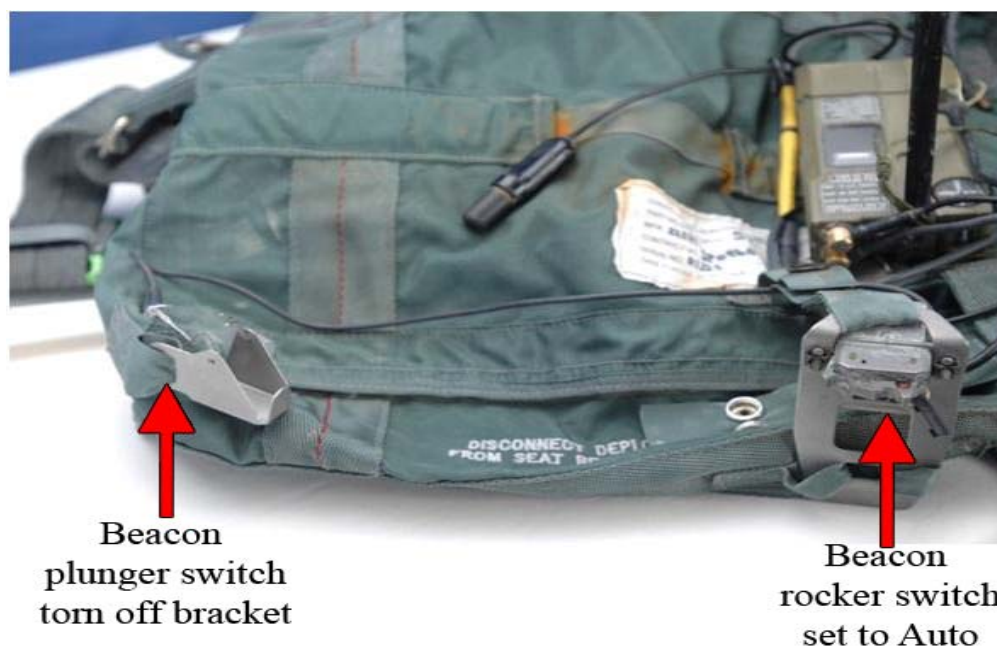
**Figure 7 (Tab DD-181, text added by AIB)**

The ACES II Ejection Seat contains a PLB intended to transmit emergency notification and location information via line-of-sight Ultra High Frequency (UHF), Very High Frequency (VHF), and beyond-line-of-sight satellite frequencies. The PLB has automatic and manual modes. The Radio Beacon Selector switch controls PLB mode selection and is located through a cutout in the front of the seat pan. The switch is a rocker switch with two settings, MAN and AUTO. With MAN selected, the radio beacon will not activate at man-seat separation (Tab DD-181). With AUTO selected, the radio beacon activates at man-seat separation (Tab DD-67). The PLB from the MA seat did not function as designed. The MP's PLB did not alert any local aircraft or radar stations via the emergency guard frequencies of 243.0 and 121.5 (Tab N-26). The recovered MA ejection seat showed the PLB selector switch was set to AUTO (Figure 7, Tab DD-67).

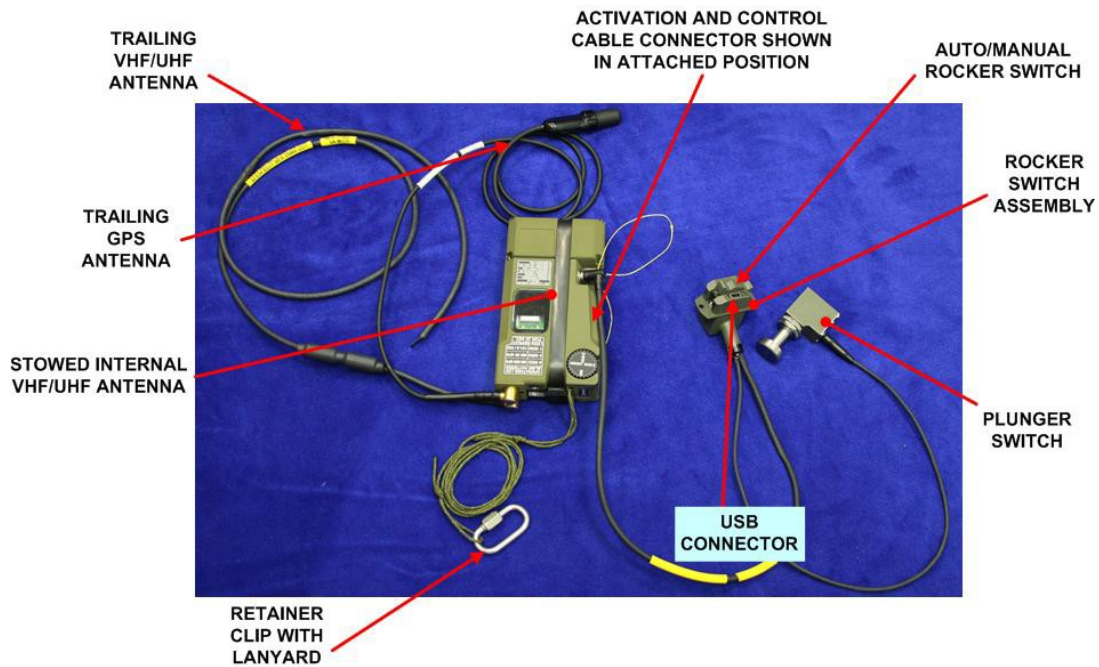
**Figure 8 (TAB Z-7)**

The plunger switch on the survival kit container, which activates the PLB at man-seat separation, was ripped off the bracket and the wires that attached it to the kit (Tab DD-181 and DD-182). The bracket on the seat pan lid that pushes the plunger switch down when the lid is closed may have caused the PLB damage (Tabs DD-161, DD-185, and DD-186).

**Activation and Control Cable Attached to PLB**

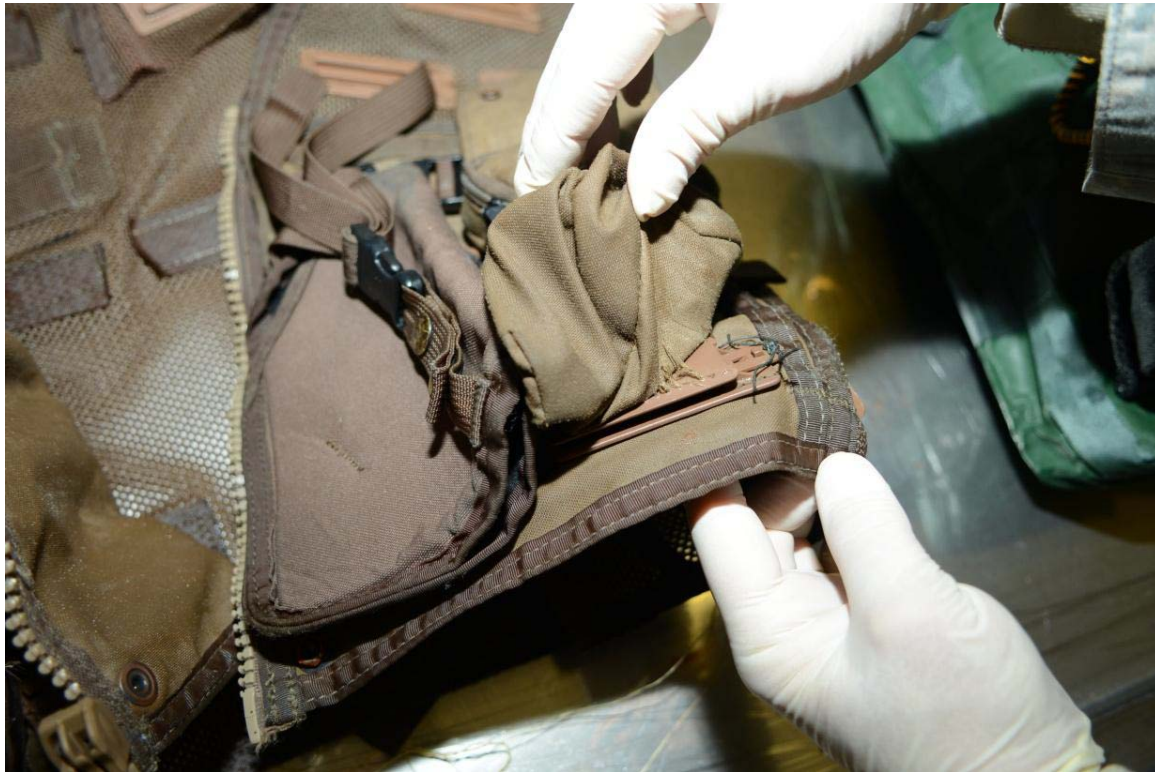
**Figure 9**

The MP's survival vest sustained minor damage during the ejection. Stitching on three of the pocket rails were broken, but the pockets were still fully attached on the vest (Tab Z-2). There is no evidence to suggest the MP attempted to access or utilize the survival radio (Tab Z-2).

**Broken stitches on MP's survival vest pockets (Tab Z-2)**

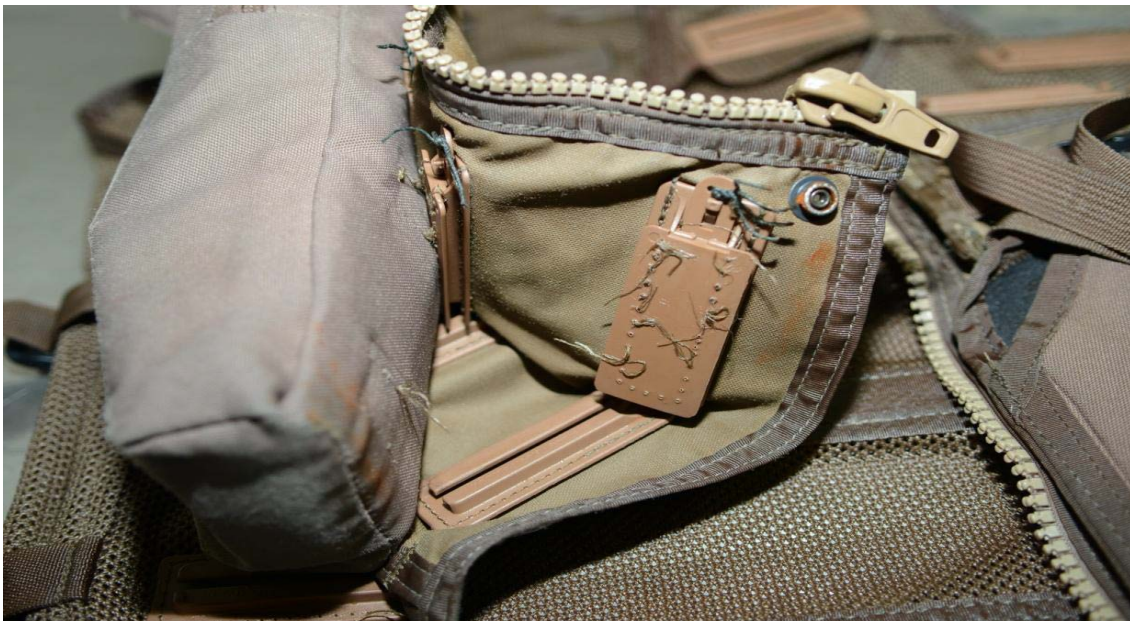
**Figure 10**

**Broken stitches on MP's survival vest pockets (Tab Z-2)**

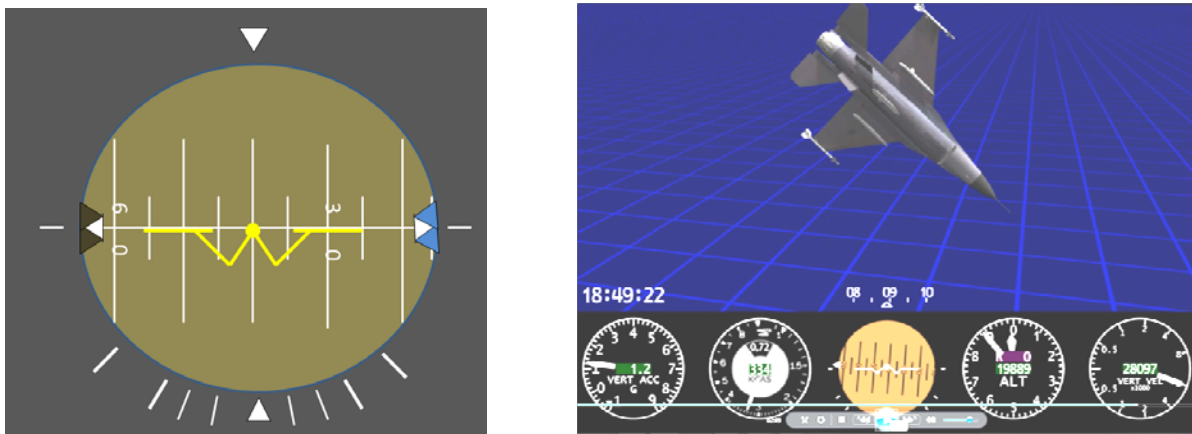
Figure 12 depicts the appearance of the main ADI seven seconds prior to the MP declaring that he was spatially disoriented (Tab DD-8 and N-17). The MP would have seen a brown field with no blue horizon when prompted by the MW to refer to the round dials (Tab N-17). Evidence shows that the MP aligned the aircraft with the horizon bar but incorrectly interpreted which way was up (Tab DD-9). Transition from NVGs to the round dials once the MA attitude was greater than 25 degrees below the horizon left the MP with fewer cues as to which direction to turn for the most efficient recovery and may explain why the MP initially turned in the wrong direction.

**Figure 12. MA at 19:49:06L – 40 degrees nose low and 90 degrees left bank.**  
(The depictions on the right list times that are 59 minutes and 44 seconds in error from the actual mishap time sequence (Tab DD-5).)

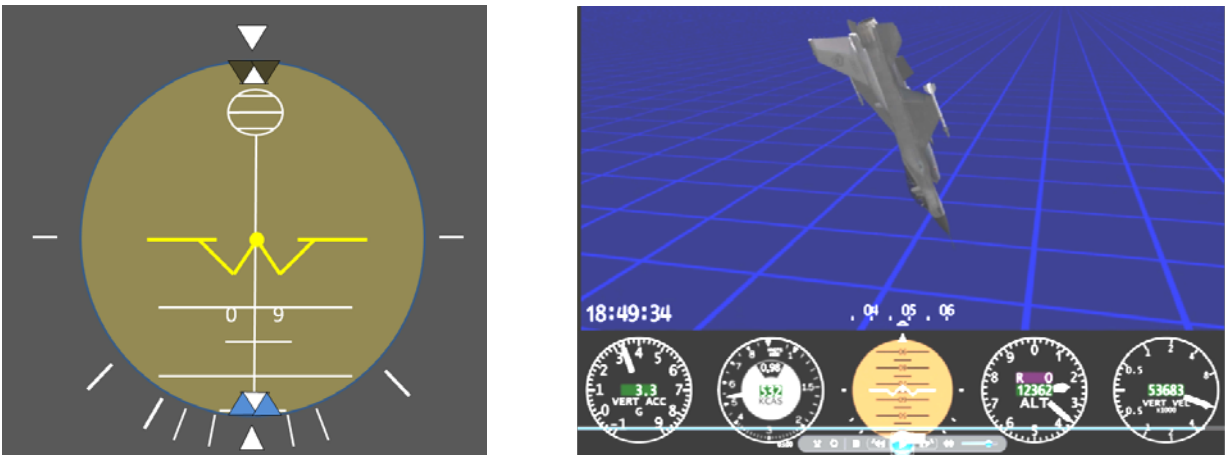
Once the MP reached 70 degrees nose low, a round ball appeared in the ADI indicating a straight down pointing at the earth direction referred to in Figure 13. The MP reoriented the MA to the correct horizon within one second of the time that the “earth” ball would have come into view in the ADI (Tab DD-9).

**Figure 13. MA at 19:49:18L – 70 degrees nose low and 180 degrees bank.**  
(The depictions on the right list times that are 59 minutes and 44 seconds in error from the actual mishap time sequence (Tab DD-5).)

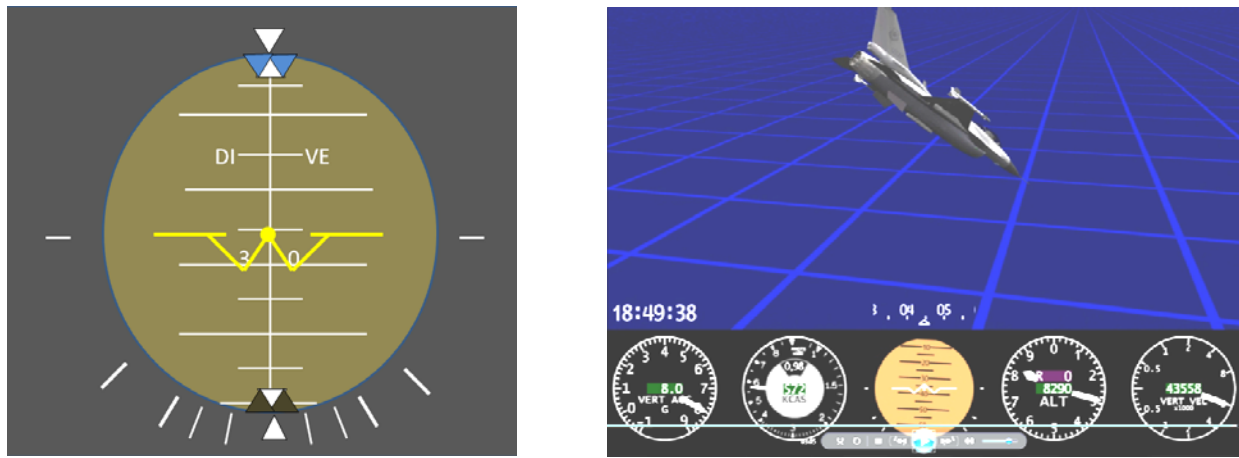
The ejection seat left the MA at 19:49:25L as the MA approached 16 degrees nose low at just over 7,000 feet and 569 knots (Tab DD-9). At the time of ejection, the MA was essentially recovered from its unusual attitude and the MA flew for an additional four miles before impacting the water (Tabs DD-9 and S-3). Human response time-lag reasonably approaches one second or longer. Response lag is the delay between perceiving the need for an action and being able to execute the action. (see, *Fundamentals of Aerospace Medicine, 4th Edition*, Jeffrey R. Davis, Robert Johnson, Jan Stepanek, Jennifer A. Fogarty Lippincott, Williams & Wilkins, Philadelphia, 2008, p. 364). Flight data also shows a decrease in demanded G forces one second prior to ejection indicating the MP had likely let go of the controls. Therefore it is likely that the MP initiated ejection at 19:49:23L at which time the MA was 25 degrees nose low, 7,900 feet

and 568 knots (Tab DD-9). This attitude is depicted in Figure 14 below. Note the lack of blue horizon.

**Figure 14. MA at 19:49:22L – 25 degrees nose low and wings level (3 seconds prior to ejection). (The depictions on the right list times that are 59 minutes and 44 seconds in error from the actual mishap time sequence (Tab DD-5 ).)**
