**UNITED STATES AIR FORCE**  
**AIRCRAFT ACCIDENT INVESTIGATION**  
**BOARD REPORT**

**F-16CM, T/N 88-0510**

**31ST FIGHTER WING  
AVIANO AIR BASE, ITALY**

**DATE OF ACCIDENT: 28 JANUARY 2013**

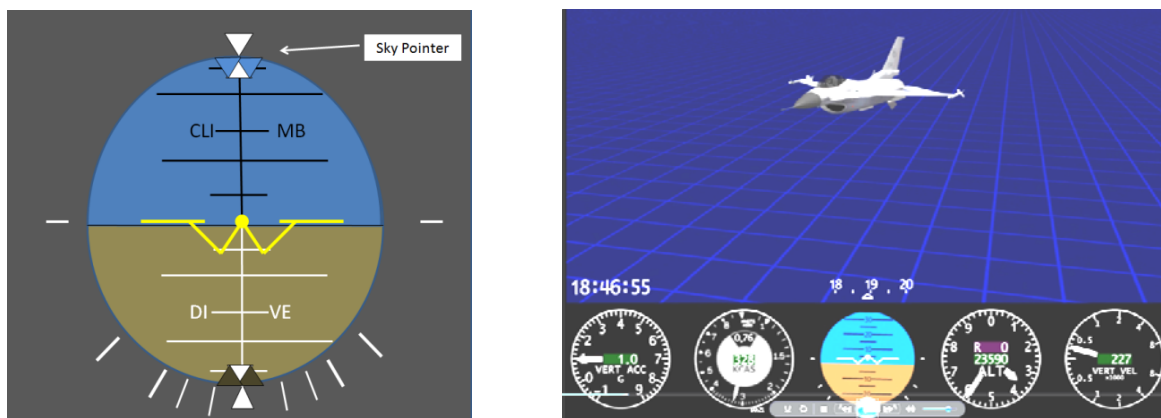
**Figure 11. Straight and level flight. Tab Z-8**

The F-16 Attitude Direction Indicator (ADI) is the primary flight instrument giving the pilot an artificial awareness of the horizon and was the primary instrument to which the MW was referring when he instructed the MP “to get on the round dials” (Tab N-17). Note that in the aircraft, the ground is indicated by the color brown and the sky is indicated by the color blue. The horizon line between the brown and blue fields is a strong cue to the horizon and gives an excellent indication of how far the horizon is from the nose of the aircraft (indicated by the dot in the middle of the yellow W symbol) (Tab DD-146). The ADI is depicted below for level flight (Figure 11).
