DOT/FAA/AR-08/25

Safety Study of Wire Strike Devices Installed on Civil and Military Helicopters

September 2008

Final Report

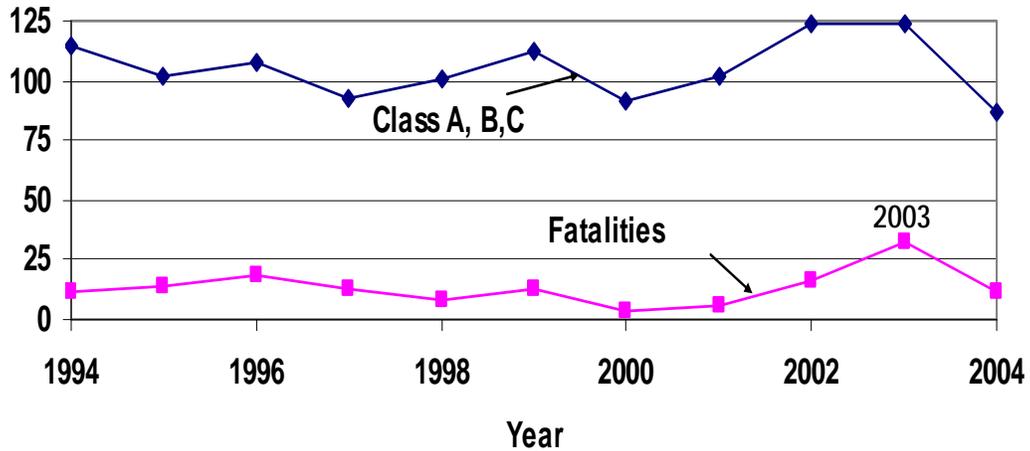
Figure 1 shows the total number of helicopter accidents in each year from 1994 through 2004. The number for 2003 is high due to the accidents that occurred in Kuwait and Iraq since the beginning of Operation Iraqi Freedom. The accidents and the number of fatalities show an increasing trend after the year 2000.

Figure 1. Total Number of U.S. Army Helicopter Accidents and Fatalities (1994-2004)

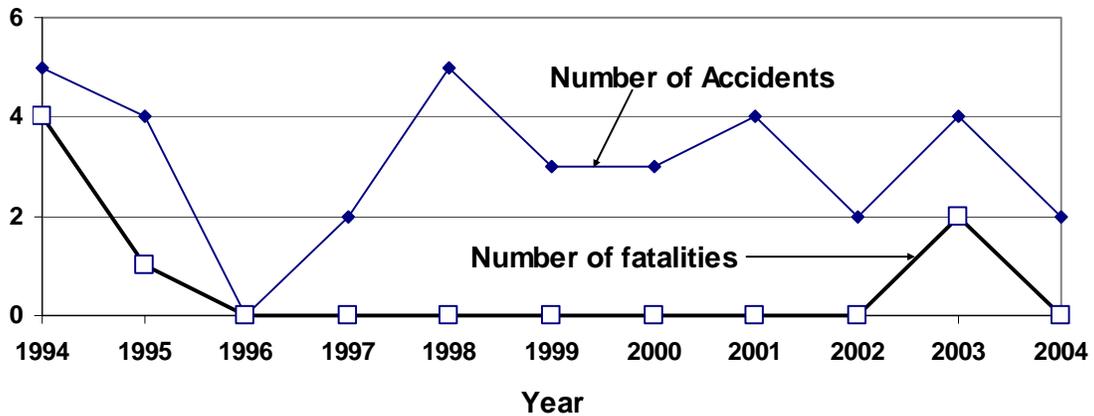
Figure 2 shows the yearly number of wire strike accidents. Between 1997 and 2002, the number of wire strike accidents was between two and five per year. Figure 2 also shows the number of fatalities in wire strike accidents. After 1995, there were no fatalities in accidents involving wire strikes, even though the number of wire strikes did not decrease. There were two fatalities in 2003 that involved an AH-64A model that was conducting a night reconnaissance and surveillance mission using night vision systems. One reason for this impressive safety record can be the installation of wire cutters (WSPS) on Army helicopters.

Figure 2. U.S. Army Helicopter Wire Strike Accidents and Fatalities

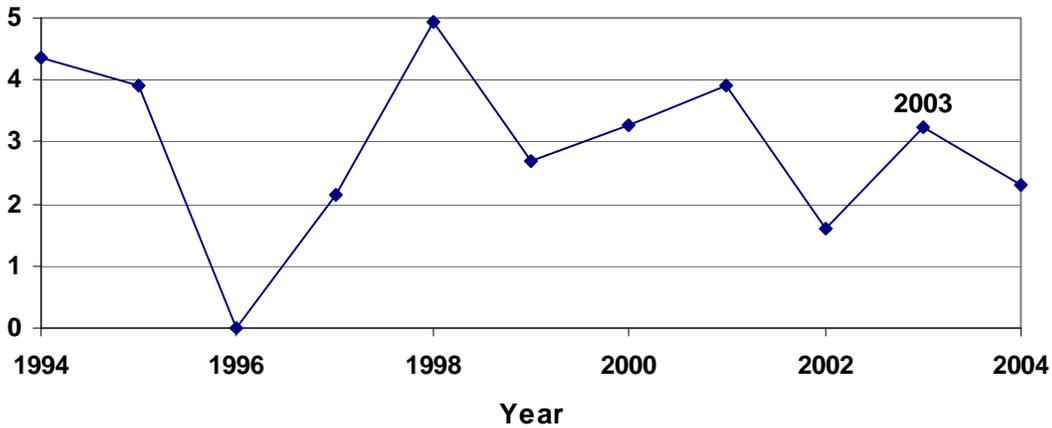
Figure 3 shows wire strike accidents as a percentage of the total number of accidents. There has been a continuous decrease in the wire strike accidents from about 1998. Wire strikes only constituted about 2% and 3% of all the helicopter-related accidents during the last 3 years (2002-2004). This rate is better than the corresponding rate for civil helicopters (between 4% and 5%).

Figure 3. U.S. Army Helicopter Wire Strike Accidents as Percentage of Total Accidents

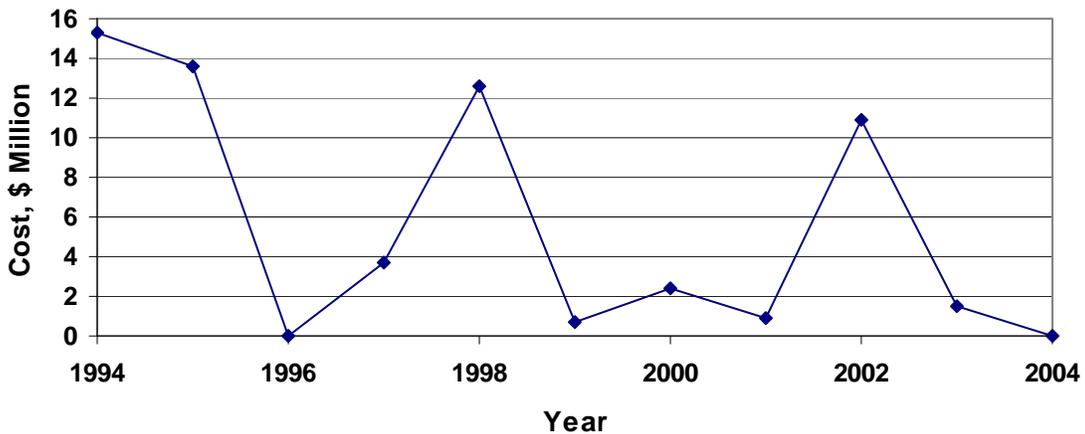
Figure 4 gives the cost incurred by the Army due to wire strike accidents. These include the cost of the damage and the costs due to injury to military personnel. There is a decrease in the costs after 1998 and is generally less than \$2 million per year. This reduction in costs is a direct result of the reduction in the number of Class A accidents.

Figure 4. Yearly Costs of U.S. Army Helicopter Wire Strike Accidents

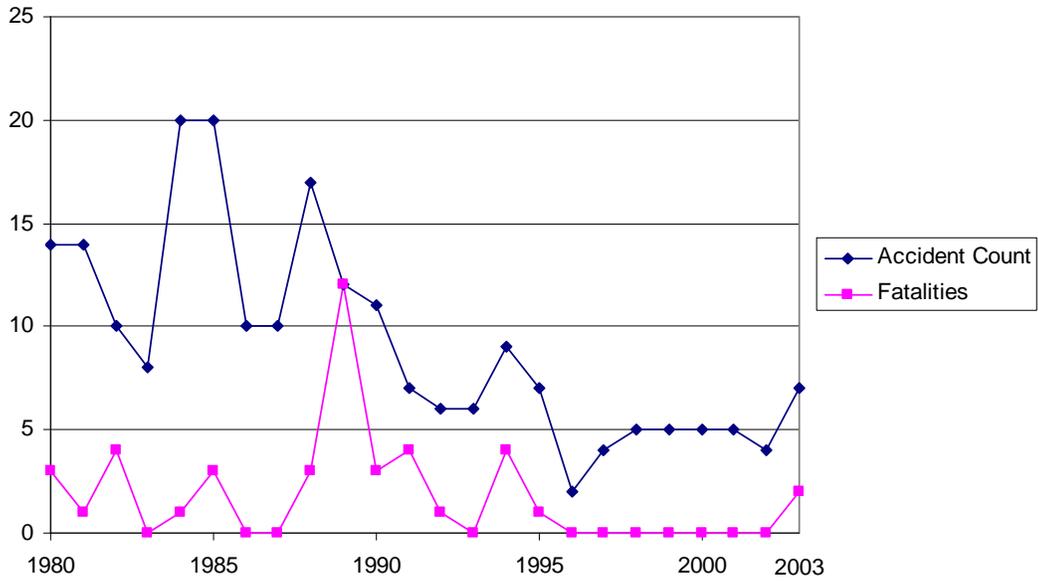
By examining the number of wire strike accidents and resulting fatalities occurring before and after the years in which WSPS units were installed, a picture of the effectiveness of the system emerges. Figure 5 shows the annual number of Army wire strike accidents (Class A-D) and the fatalities in these accidents from 1980 to 2003.

Figure 5 shows that the annual number of wire strike accidents decreased after 1990. Between 1980 and 1990, the number of wire strikes varied between 8 and 20 accidents per year. After 1990, the number of accidents was reduced to below 10 per year, stabilizing at 5 per year. The reduction in accidents can be attributed to the improved awareness of the pilots to wire strike possibilities after WSPS was installed. The number of fatalities in these accidents shows a dramatic decrease after 1994. Between 1996 and 2002, there were no fatalities. However, because the database does not contain narrative details of all the accidents, it is not possible to ascribe these reductions solely to the installation of WSPS.

Figure 5. U.S. Army Wire Strike Accidents 1980-2003

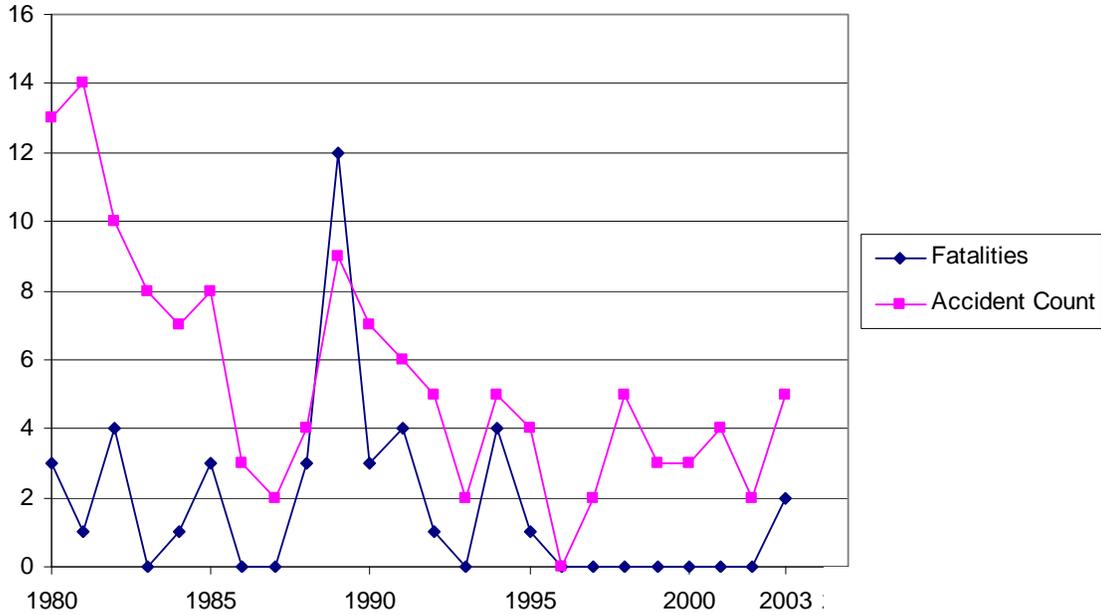
To determine whether the WSPS prevents the more serious accidents in a similar manner, the accidents in Classes A-C were examined over the same time span. The results are shown in figure 6.

Figure 6. U.S. Army Wire Strike Accidents, Class A-C

Figure 6 shows that there is a significant drop in the annual number of accidents after 1990. This reinforces the conclusion that the reduction in number of wire strikes and the elimination of fatalities in these accidents occurred after the installation of WSPS.

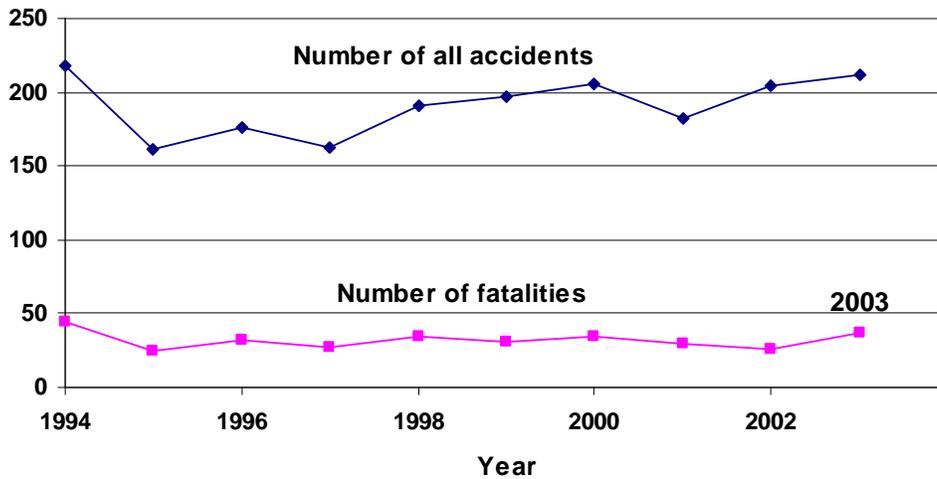
Table 2 shows data on the accidents in which U.S. civil helicopters were involved from 1994-2003. The total number of hours flown per year shows an increase trend up to 1999 and then a decrease from a peak of 2.74 million hours in 1999 to slightly above 2.1 million hours per year between 2001 and 2003. Figure 7 shows the number of accidents and the number of fatalities per year from 1994 to 2003. The total number of accidents shows an increasing trend from 1997 onwards. There were 212 accidents involving 67 fatalities in the year 2003.

Figure 7. U.S. Civil Helicopter Accidents: Number of Accidents and Number of Fatalities per Year

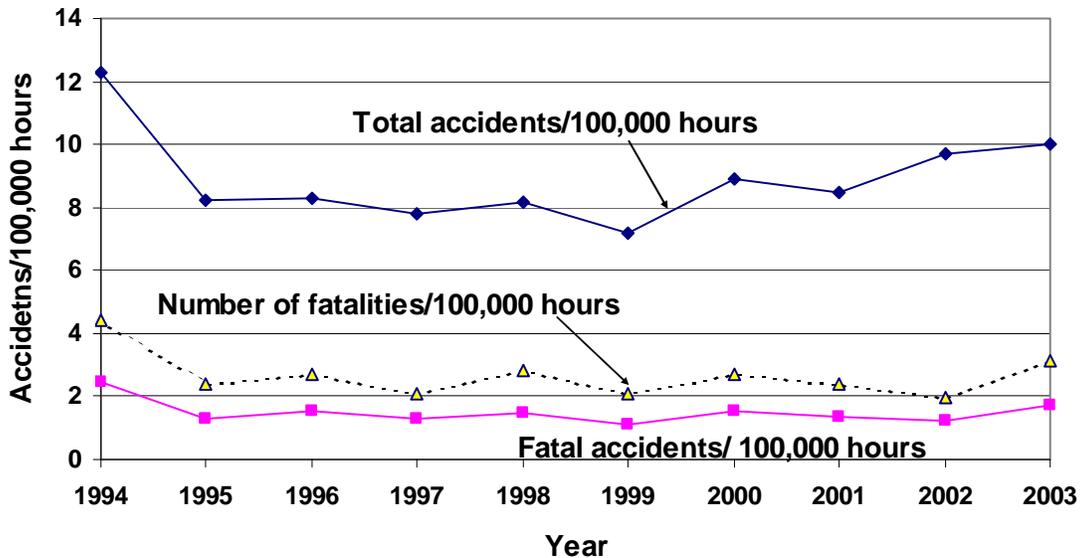
A commonly used safety metric is the number of accidents per 100,000 flight hours (total number of accidents/total flight hours/100,000). Figure 8 shows the rate of the total accidents, total number of fatal accidents, and the number of fatalities per 100,000 flight hours. All these metrics show an increasing trend from about 1999.

Figure 8. U.S. Civil Helicopter Accidents: Trend of Number of Accidents, Number of Fatalities, and Number of Fatal Accidents per 100,000 Flight Hours

The rate of accidents in 2003 was close to ten accidents per 100,000 flight hours. There were 1.74 fatal accidents per 100,000 hours in the year 2003. The corresponding rates for fixed-wing aircraft operated by air carriers under 14 CFR 121 are shown in figure 9. In the year 2003, the number of accidents for fixed-wing of aircraft was slightly above 0.3 accidents per 100,000 flight

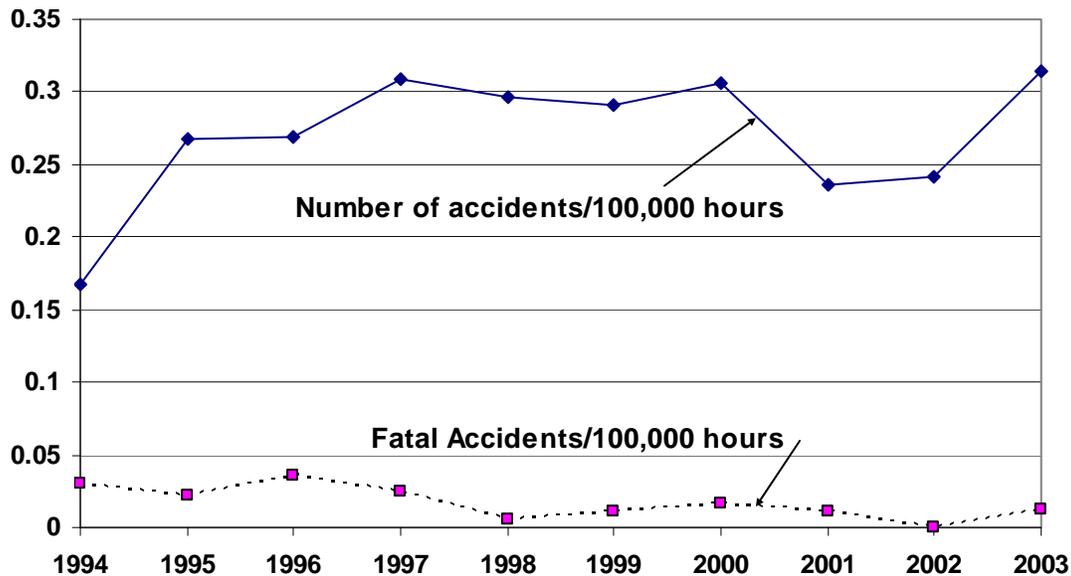
hours. Thus, the rate of accidents per 100,000 hours for fixed-wing aircraft is 3% of the accident rate for helicopters.

Figure 9. Accident Rates, 1994 Through 2003, for U.S. Air Carriers Operating Under 14 CFR 121

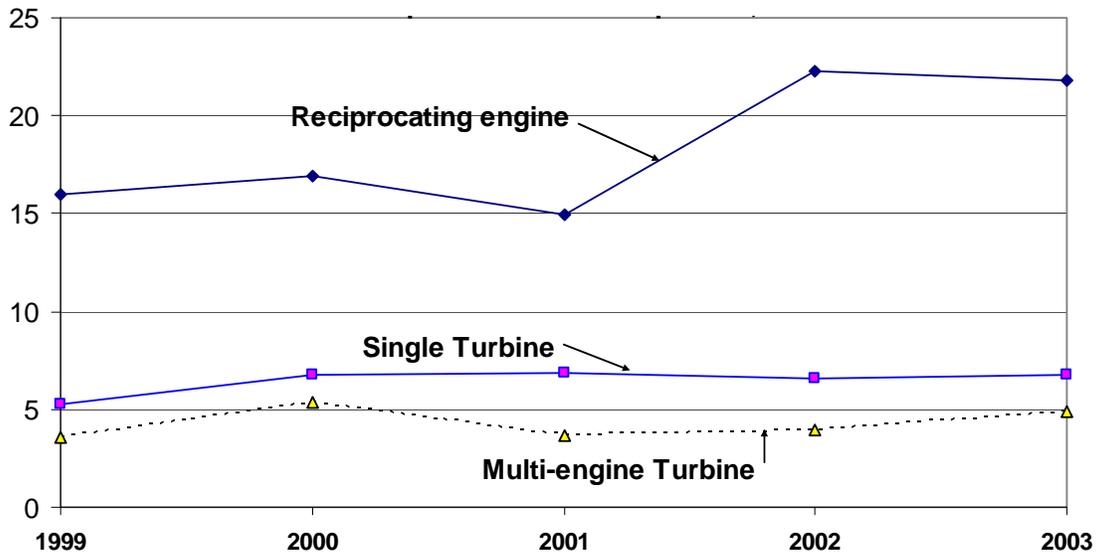
The U.S.-registered civil helicopter fleet consists of helicopters powered by single reciprocating engines, single turbine engines, and multiple turbine engines. Figure 10 shows the accident rate (per 100,000 hours) for each of these types of helicopters. There has been a sharp increase in the number of accidents involving single reciprocating engine helicopters. The multiengine helicopters have been involved in the lowest number of accidents per 100,000 hours; this rate is also showing an increasing trend, about five accidents/100,000 hours in 2003.

Figure 10. U.S. Civil Helicopter Accident Rates by Engine Type

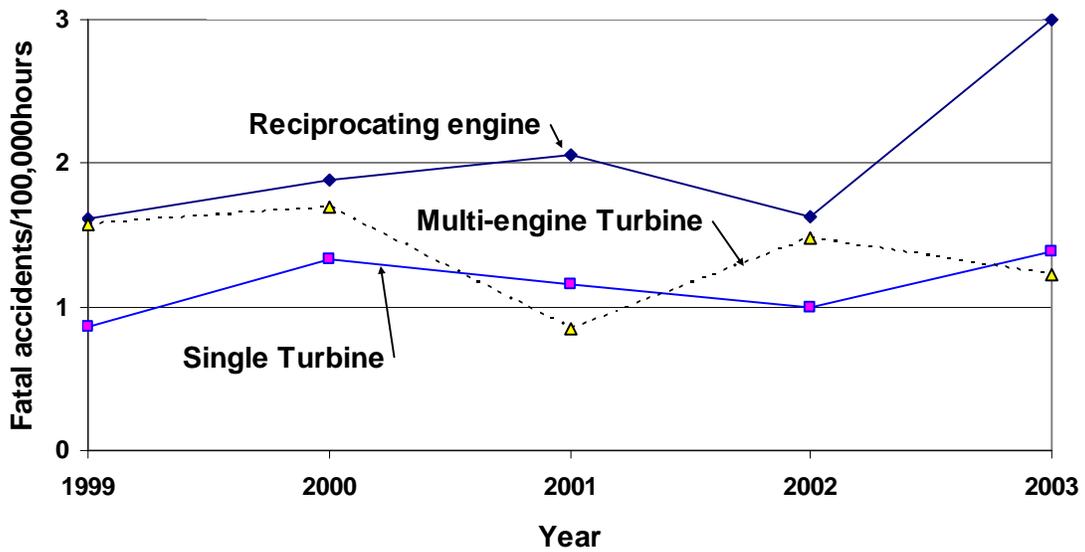
Figure 11. U.S. Civil Helicopter Accidents: Fatal Accidents/100,000 Flight Hours by Engine Type

Figures 11 and 12 show the number of fatal accidents and the number of fatalities per 100,000 hours for the three types of helicopters. Helicopters with reciprocating engines appear more susceptible to accidents involving fatalities per 100,000 hours.

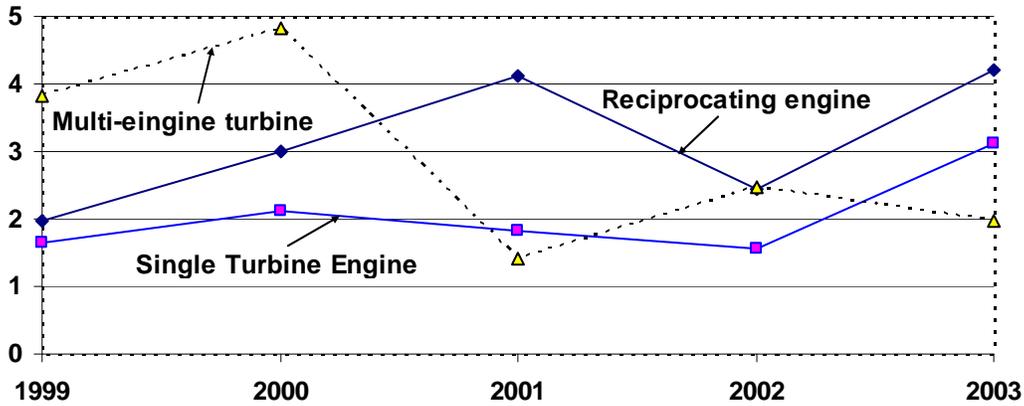
Figure 12. U.S. Civil Helicopter Accidents: Fatalities/100,000 Flight Hours by Engine Type

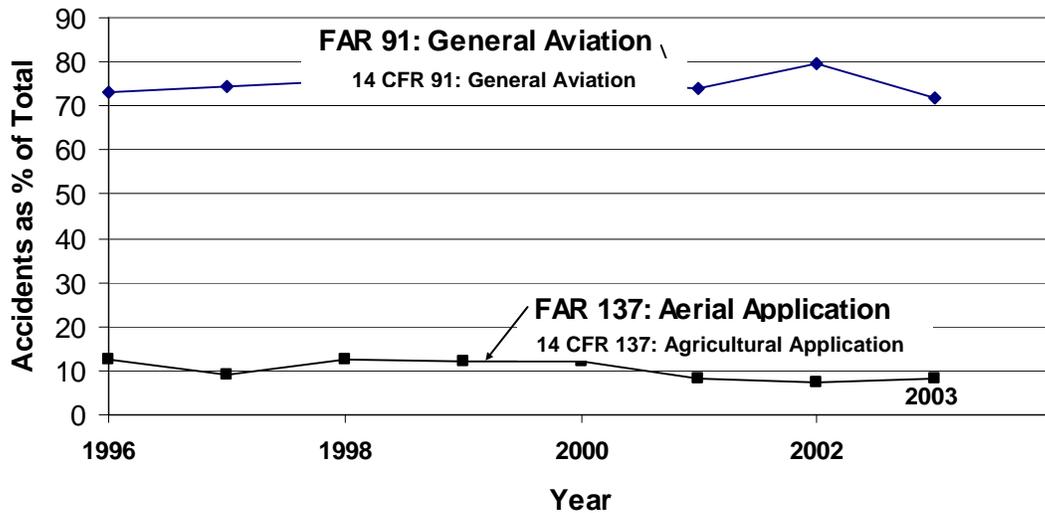
Figure 13 shows the accidents in which helicopters conducting 14 CFR Part 91 (general aviation) and 14 CFR Part 137 (agricultural application) operations were involved. Helicopters conducting general aviation operations were involved in 70% to 80% of all civil helicopter accidents. Helicopters involved in agricultural application operations accounted for about 10% of all the accidents.

Figure 13. U.S. Civil Helicopter Accidents by Type of Operation

As a comparison, the percentage breakdown of civil helicopter accidents was general aviation: between 70% and 80% and agricultural: 10% (figure 13).

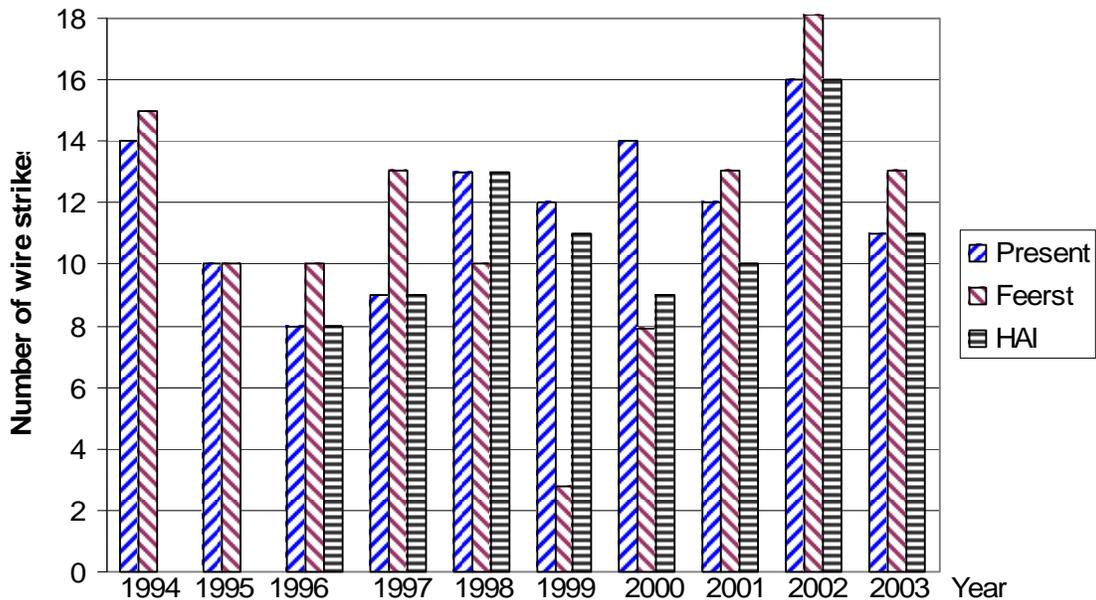
As mentioned in section 3.2.1, a number of key words need to be used when querying the NTSB database to compile a report on a particular type of accident. Because researchers do not use the same keywords to query the database, the result is different statistics being quoted by different researchers. For example, figure 14 shows a comparison of accident data generated in the present study with similar data from Freest [11] and HAI [12]. Even though there is a difference in the number of accidents reported per year, there is fair agreement between the three sets of data.

Figure 14. Comparison of Yearly U.S. Civil Helicopter Wire Strike Accidents Obtained in Three Different Studies

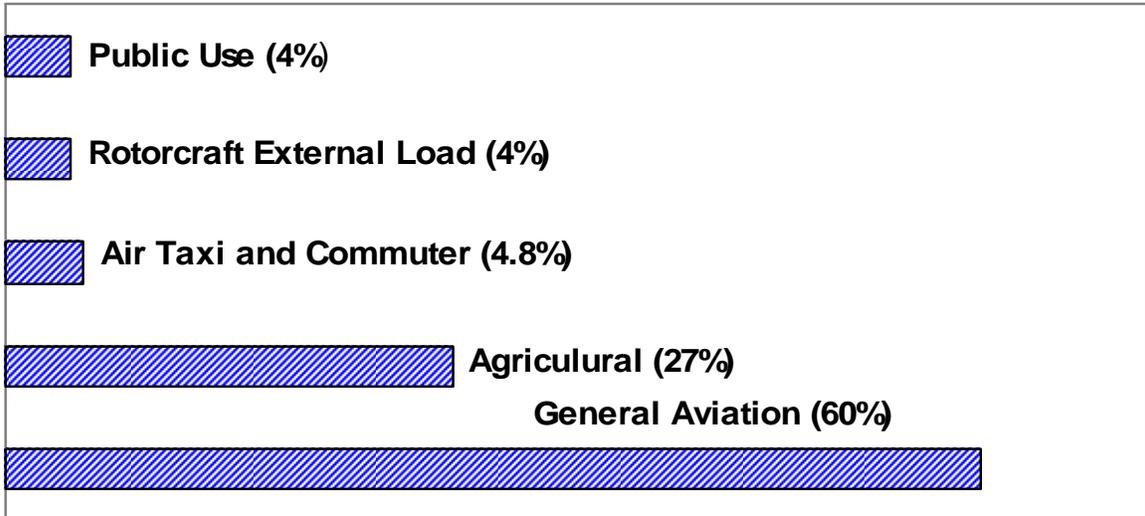
Table 7 provides a comparison of wire strike accidents by the type of operation for the two periods: 1970-1979 and 1994-2003. In 1970-1979, general aviation operations accounted for 42% of the wire strikes, while agricultural operations accounted for about 48% of all wire strike accidents. Figure 15 shows the wire strike accidents by type of operation for 1994-2003. Figure 16 shows the yearly distribution of wire strike accidents as a percentage of total in general aviation and agricultural application operations. The wire strike percentage in general aviation operations has increased since about 1999.

Figure 15. Civil Helicopter Wire Strike Accidents by Type of Operation for 1994-2003

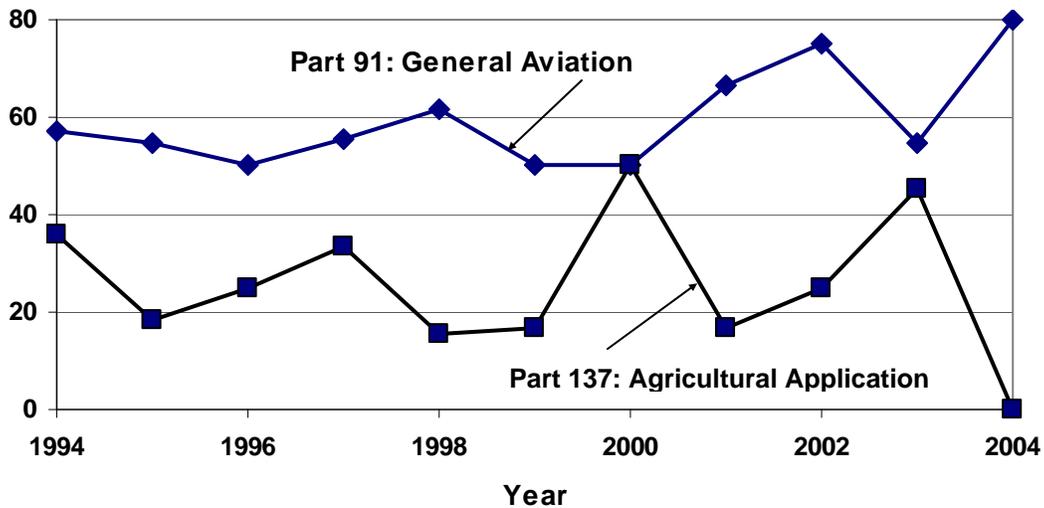
Figure 16. U.S. Civil Helicopter Wire Strike Accidents by Type of Operation

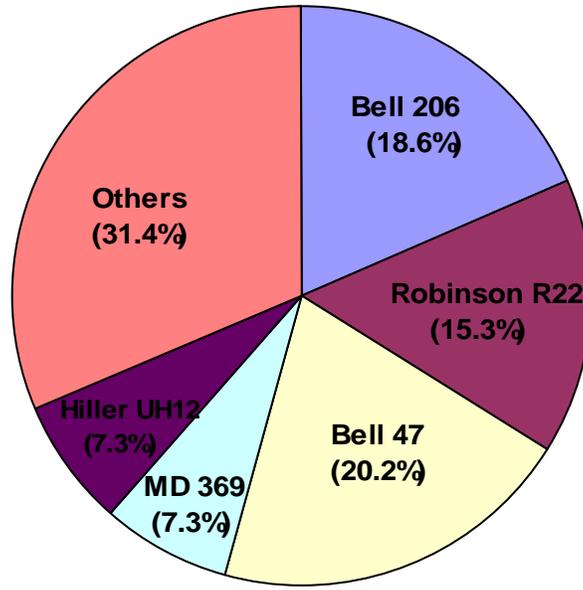
Figure 17 shows the percentage of wire strike accidents for each of the helicopter types that have been involved. The Bell 47 and its variants account for about 20% of all the wire strike accidents while the Bell 206 and its variants come close with 18.6%. The Robinson R22 (including three R44 models) accounts for another 15.3% of the accidents. Other helicopter models such as the Eurocopter AS-350 and Enstrom F280 accounted for about 31% of the wire strike accidents. Figures 18, 19, and 20 show the number of wire strike accidents for the years 1994 to 2004 for the Bell 206, Bell 47, and Robinson R22 models. Of the helicopters involved in wire strike accidents (table 8), FAA-approved wire strike protection kits (wire cutters) are available for the following models: Bell 205, 212, and 407, Eurocopter AS-350 and BK-117, and McDonnell Douglas (MD) helicopters MD-900. As shown in table 8, these helicopter models account for 32 of the 124 helicopters (25.8%) involved in wire strike accidents. FAA-approved wire cutters were not available for the other helicopters mentioned above. Thus, nearly 74% of the helicopters involved in the wire strikes could not have been fitted with wire cutters.

Figure 17. Helicopter Wire Strike Accidents by Model

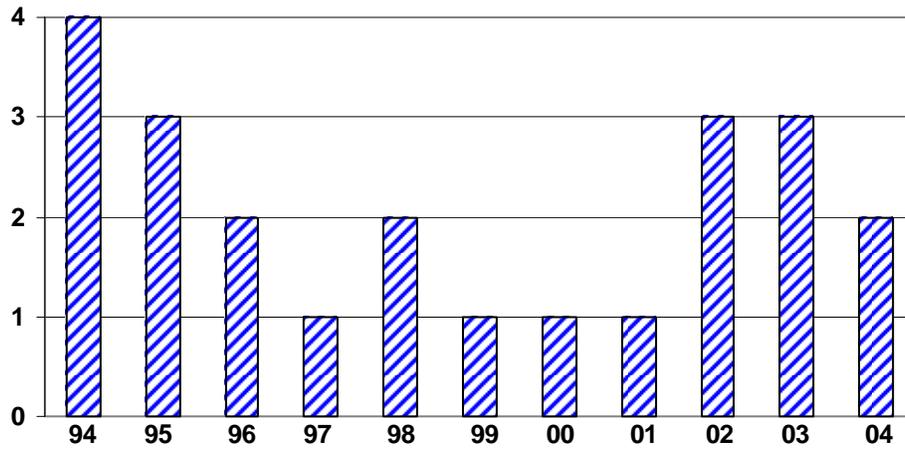
Figure 18. Wire Strike Accidents Involving Bell 206

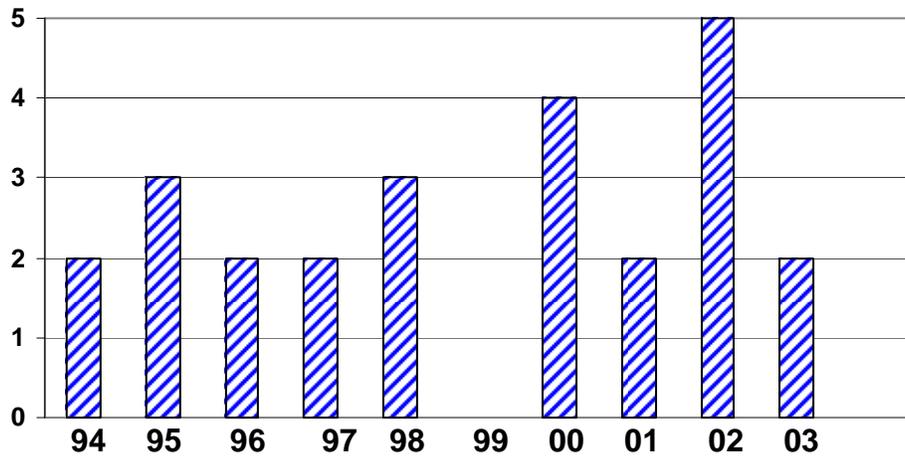
Figure 19. Wire Strike Accidents Involving Bell 47

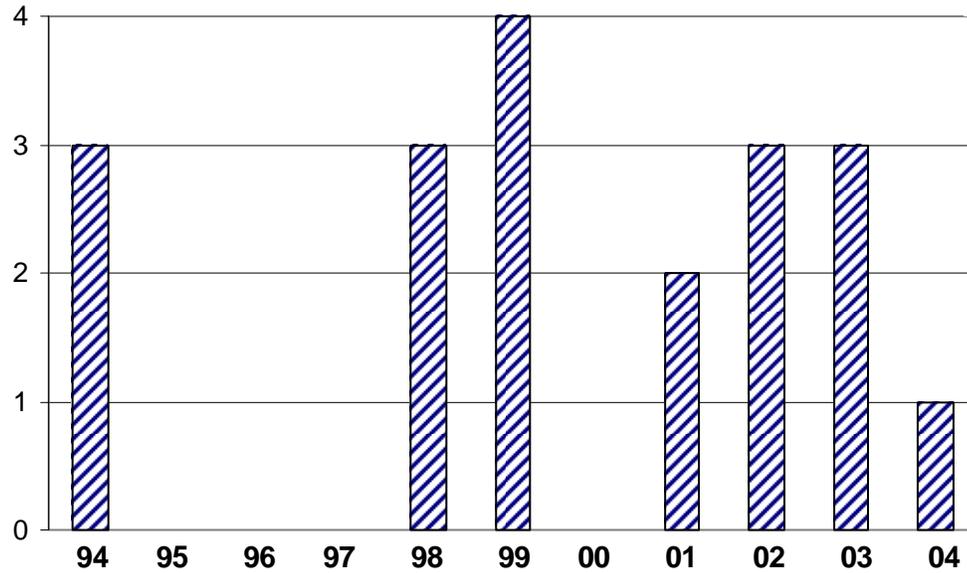
Figure 20. Wire Strike Accidents Involving Robinson R22

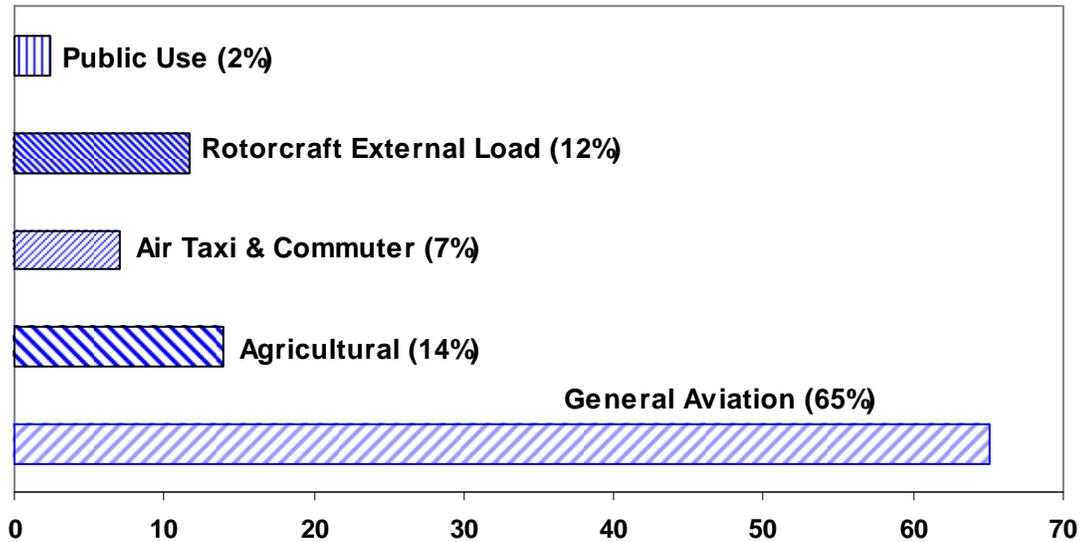
Figure 21 shows the distribution of civil helicopter fatal wire strike accidents during 1994-2003 by type of operation. Helicopters operating under general aviation (14 CFR Part 91) account for 65% of all fatal wire strike accidents. Agricultural operations (14 CFR Part 137) and rotorcraft external load (14 CFR Part 133) account for 14% and 12% of the fatalities.

Figure 21. U.S. Civil Helicopter Fatal Accidents by Operation (1994-2003)

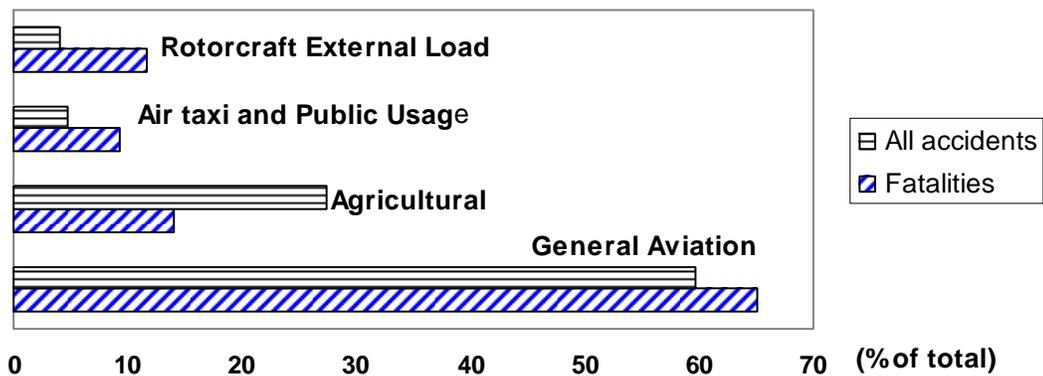
Figure 22 shows a comparison of the proportion of all wire strike accidents (as percentage of the total) with the fatalities in each type of operation. Operations under 14 CFR Part 91 general aviation account for about 65% of wire strike accidents and for about 60% of the fatalities. Agricultural operations account for about 27% of wire strike accidents and about 14% of fatalities in wire strikes (14 CFR Part 137).

Figure 22. Comparison of Accidents and Fatalities by Type of Operation (1994-2003)

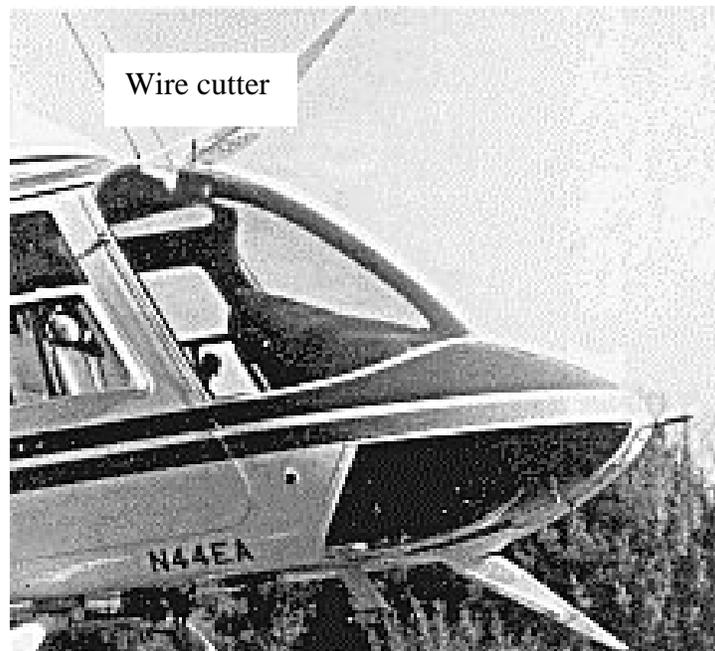
Wire impacts have serious consequences to helicopters. For example, a power transmission cable can slice through the windshield if the helicopter impacts the cable at sufficient forward speed. One system that can provide a degree of protection to the helicopter in frontal impacts is the WSPS, manufactured by Bristol Aerospace Limited. A typical installation consists of a roof-mounted cutter and one or more cutters mounted on the fuselage of the helicopter. A deflector running vertically along the middle of the windshield guides the cables into the cutters. Figure 23 shows the system installed on a Bell 206.

Figure 23. The WSPS Installed on a Bell 206 [13]

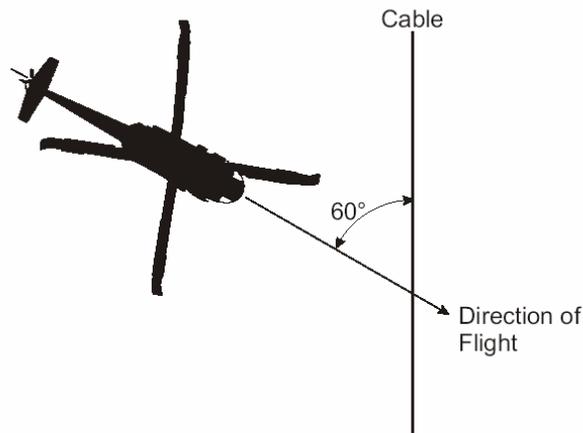
For the cutters to be effective, the helicopter must be flying at speeds greater than 30 knots [14]. The manufacturer states that if a helicopter with a WSPS impacts a wire at an angle less than 60° to the wire, the WSPS may not cut the wire (figure 24). In addition, the maximum pitch angle at which the WSPS should strike the wire and still be effective is $\pm 5^\circ$. The system is designed to cut a 3/8-inch steel cable with a breaking strength of 12,000 lb [14].

Angle Strike Design Parameters

Figure 24. Maximum Wire Strike Angle [15]

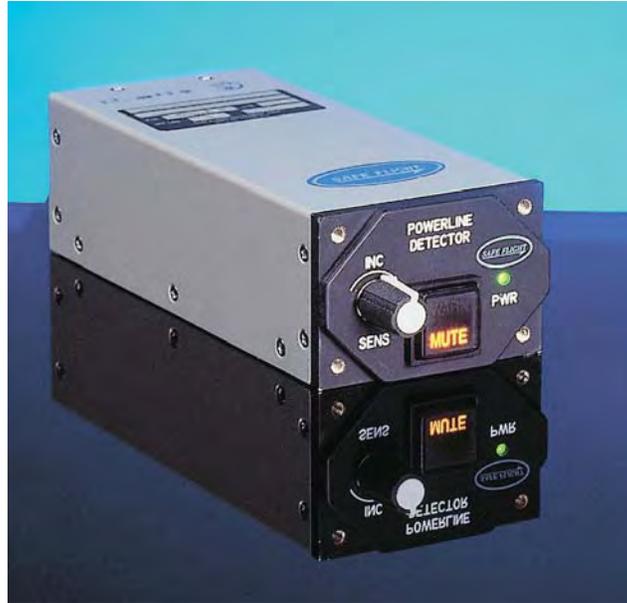
The Powerline Detector, manufactured by Safe Flight Instrumentation Corp., is a system that senses the electromagnetic fields surrounding power lines and uses this information to alert the pilot to the proximity of wires. The system consists of an electronics unit mounted in the cockpit (figure 25) and a whip antenna mounted on the fuselage. The antenna can be placed on the nose, roof, or tail boom of the aircraft. The electronic unit measures 1.66" x 2.42" x 5.51", and the total system weight is approximately 3 pounds [17].

Figure 25. Powerline Detector Electronics Control [17]

If a power line is detected in the flight path, the system gives the pilot an audible warning starting from a distance of 1800 feet from the hazard. The warning sound increases in frequency as the power line gets closer. If the pilot continues to approach the power line, a red warning light illuminates in the cockpit. The system can be temporarily muted when flying in an area where there are a number of power lines [17].

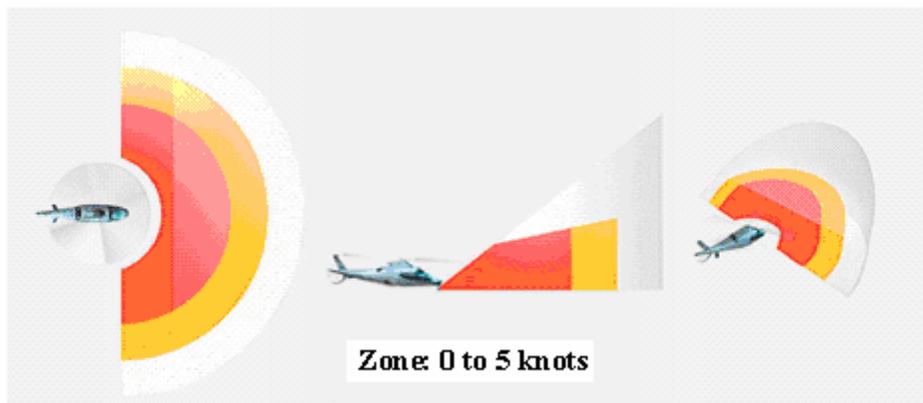
Figure 26. Zones of Scan, OASys (Hover to 5 knots)

The OASys radar (Amphitech Systems) uses a radar mounted on the nose of the helicopter to transmit a 35-GHz radio frequency for detecting obstacles in the flight path. The radar constantly searches for obstacles in its field of view. At a given instant of time, the system uses data from the aircraft's GPS receiver to calculate the aircraft's flight path for the succeeding 19 seconds. Three zones of increasing potential risk are then designated by the system. If the obstacle is located in any of these three zones, the pilot is given a level of alert that depends on the proximity and zone of the obstacle and is notified by a small display in the cockpit that illuminates in accordance with the distance and direction to the obstacle. OASys also adapts to the requirements of the flight. For instance, during takeoff, the system scans a wide angle around the helicopter, but only a short distance in front of it. However, when the aircraft is cruising at high speeds, the scan narrows, but looks far ahead in the flight path [10]. These zones are shown in figures 26 and 27.

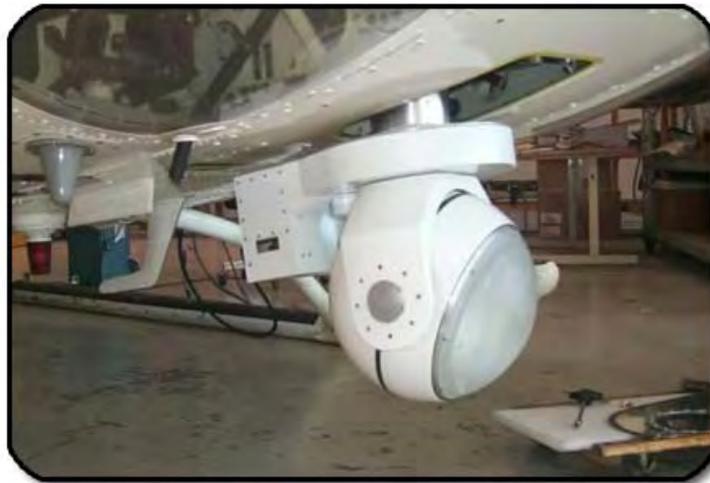
Figure 28. The OASys Scan Head [19]

The OASys radar has a maximum range of 1600 meters, an optimal range of 800 meters, and a minimum range of 2 meters. This system is also effective in rain and fog. The physical unit consists of an electronics box mounted inside the helicopter and a sensor mounted on the nose of

the helicopter (figure 28). The sensor dimensions are 15.48" x 16.78" x 22.44", and the total weight is approximately 54 pounds.

Though the mounted sensor may be large, it produces little added drag on the helicopter (see figure 28). The manufacturer, Amphitech, estimates that there will be a loss of 1 knot when cruising at 140 knots. OASys does not detect objects behind or directly above the aircraft. Thus, the system will not warn the pilot of wires near the tail rotor while hovering or taking off.

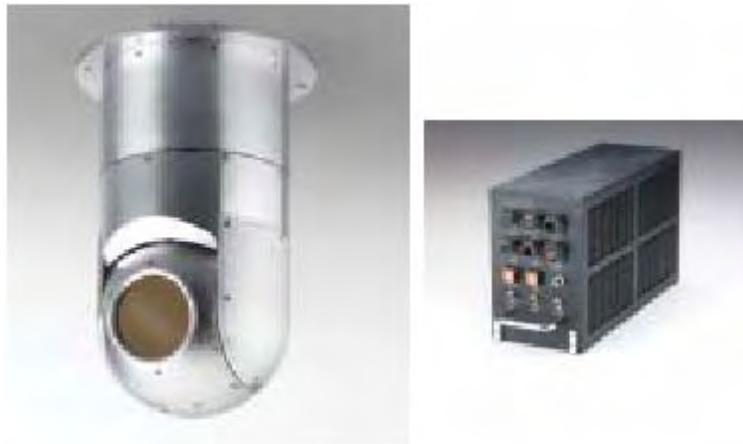
Figure 29. The LOAS Scan Head and Electronics [20]

The system has the capability of being pointed in the direction desired by the pilot [21]. The range of the system varies from 2 meters (minimum) to 2 kilometers (maximum). The scan head has a horizontal field of view of 180° and a vertical field of view of +30° to -90° [20]. The scan head and electronics box are shown in figure 29.

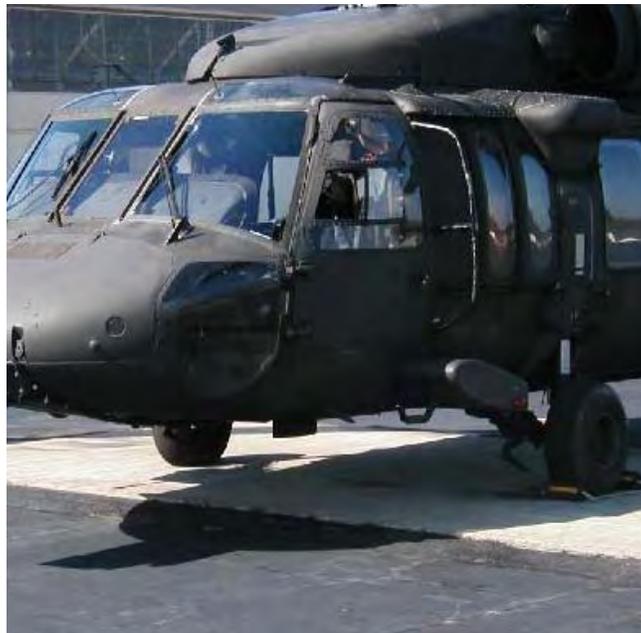
Figure 30. HELLAS Installed on UH-60 Helicopter

rotorcraft too close to the obstacle [22]. The system is connected to the helicopter by a standard interface, which requires 28 Vdc [23]. Figure 30 shows the optical display box installed on the fuselage.

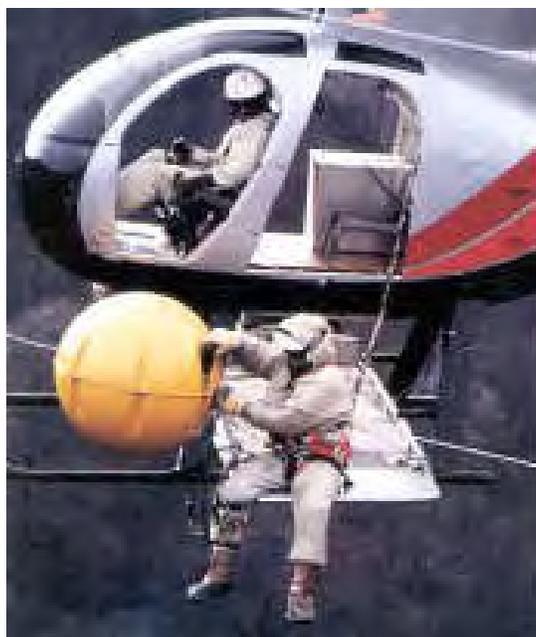
Figure 31. SpanGUARD Installation [29]

SpanGUARD Helimark Aerial markers, manufactured by P&R Technologies, are colored spherical balls that are attached to wires and power lines to make them more visually prominent to aircraft pilots. The spheres are available in orange, yellow, and white, and in varying diameters. The markers use a wire rod that wraps around the line to grip the wire. The construction includes the rods connected to the outside of the marker and lock nuts for easier live line installation. These markers use a clam shell design so that they can be installed easily by hand from a helicopter or installed before the power lines are strung up. Aerial markers should last many years. They are designed to minimize color degradation caused by the sun. P&R Technologies does not estimate an official life span for the markers, but cites several counties in the U.S. where the markers have been in place for over 20 years [28]. Figure 31 shows a marker being installed from a helicopter. The weight and cost of some spherical markers are given in table 13.
