**DOT/FAA/AR-08/25**

# **Safety Study of Wire Strike Devices Installed on Civil and Military Helicopters**

September 2008

Final Report

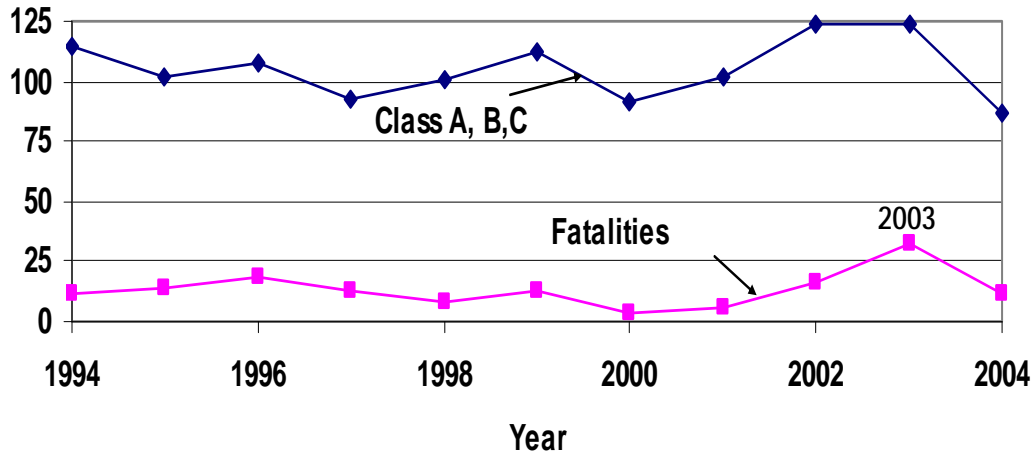
Figure 1 shows the total number of helicopter accidents in each year from 1994 through 2004. The number for 2003 is high due to the accidents that occurred in Kuwait and Iraq since the beginning of Operation Iraqi Freedom. The accidents and the number of fatalities show an increasing trend after the year 2000.

Figure 1. Total Number of U.S. Army Helicopter Accidents and Fatalities (1994-2004)

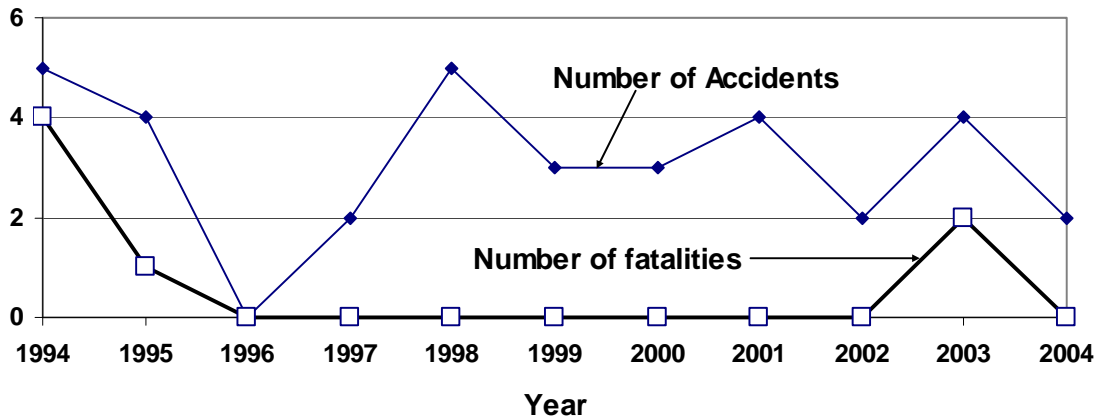
Figure 2 shows the yearly number of wire strike accidents. Between 1997 and 2002, the number of wire strike accidents was between two and five per year. Figure 2 also shows the number of fatalities in wire strike accidents. After 1995, there were no fatalities in accidents involving wire strikes, even though the number of wire strikes did not decrease. There were two fatalities in 2003 that involved an AH-64A model that was conducting a night reconnaissance and surveillance mission using night vision systems. One reason for this impressive safety record can be the installation of wire cutters (WSPS) on Army helicopters.

Figure 2. U.S. Army Helicopter Wire Strike Accidents and Fatalities

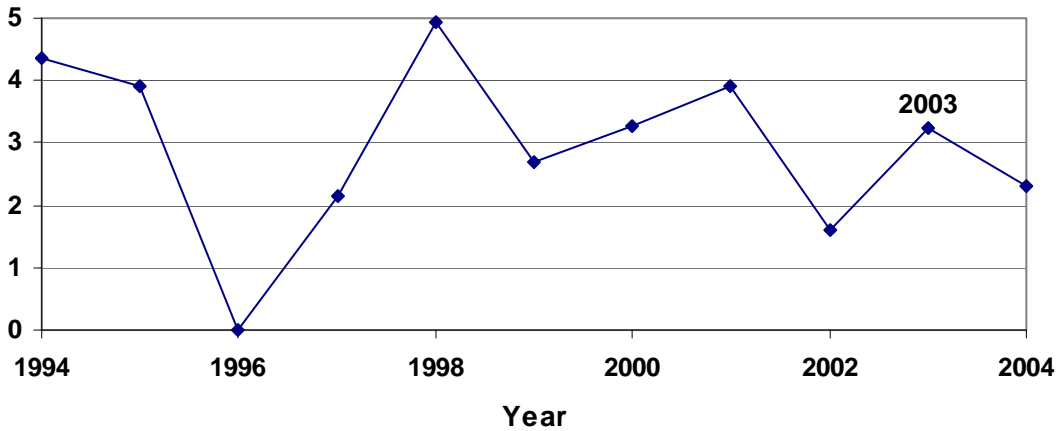
Figure 3 shows wire strike accidents as a percentage of the total number of accidents. There has been a continuous decrease in the wire strike accidents from about 1998. Wire strikes only constituted about 2% and 3% of all the helicopter-related accidents during the last 3 years (2002-2004). This rate is better than the corresponding rate for civil helicopters (between 4% and 5%).

Figure 3. U.S. Army Helicopter Wire Strike Accidents as Percentage of Total Accidents

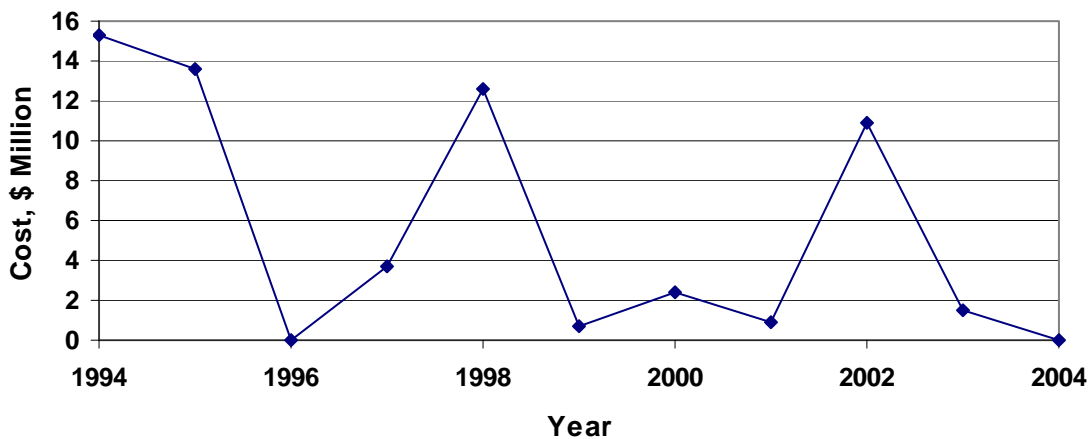
Figure 4 gives the cost incurred by the Army due to wire strike accidents. These include the cost of the damage and the costs due to injury to military personnel. There is a decrease in the costs after 1998 and is generally less than \$2 million per year. This reduction in costs is a direct result of the reduction in the number of Class A accidents.

Figure 4. Yearly Costs of U.S. Army Helicopter Wire Strike Accidents

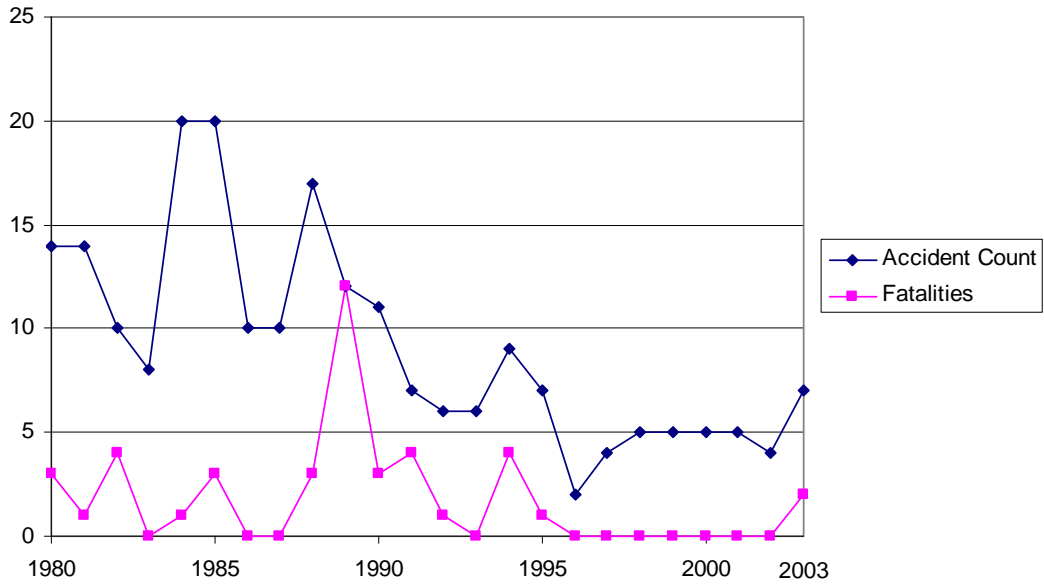
By examining the number of wire strike accidents and resulting fatalities occurring before and after the years in which WSPS units were installed, a picture of the effectiveness of the system emerges. Figure 5 shows the annual number of Army wire strike accidents (Class A-D) and the fatalities in these accidents from 1980 to 2003.

Figure 5 shows that the annual number of wire strike accidents decreased after 1990. Between 1980 and 1990, the number of wire strikes varied between 8 and 20 accidents per year. After 1990, the number of accidents was reduced to below 10 per year, stabilizing at 5 per year. The reduction in accidents can be attributed to the improved awareness of the pilots to wire strike possibilities after WSPS was installed. The number of fatalities in these accidents shows a dramatic decrease after 1994. Between 1996 and 2002, there were no fatalities. However, because the database does not contain narrative details of all the accidents, it is not possible to ascribe these reductions solely to the installation of WSPS.

Figure 5. U.S. Army Wire Strike Accidents 1980-2003

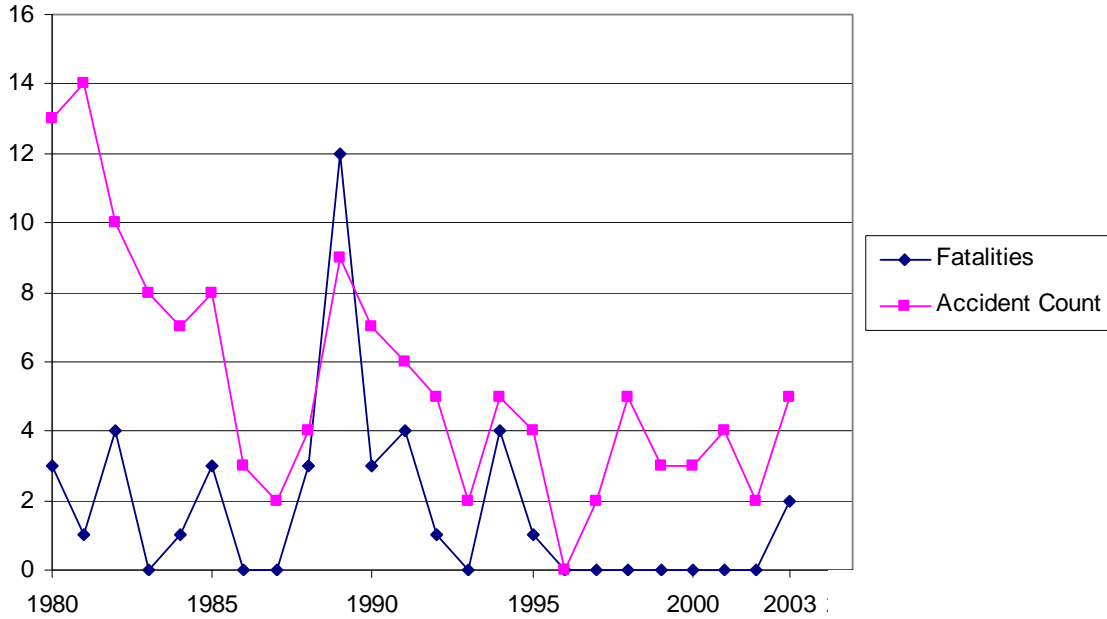
To determine whether the WSPS prevents the more serious accidents in a similar manner, the accidents in Classes A-C were examined over the same time span. The results are shown in figure 6.

Figure 6. U.S. Army Wire Strike Accidents, Class A-C

Figure 6 shows that there is a significant drop in the annual number of accidents after 1990. This reinforces the conclusion that the reduction in number of wire strikes and the elimination of fatalities in these accidents occurred after the installation of WSPS.

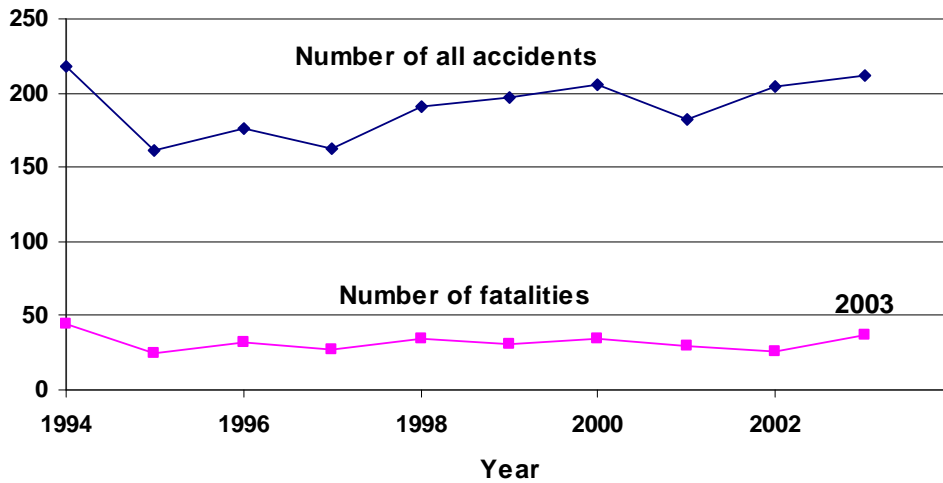
Table 2 shows data on the accidents in which U.S. civil helicopters were involved from 1994-2003. The total number of hours flown per year shows an increase trend up to 1999 and then a decrease from a peak of 2.74 million hours in 1999 to slightly above 2.1 million hours per year between 2001 and 2003. Figure 7 shows the number of accidents and the number of fatalities per year from 1994 to 2003. The total number of accidents shows an increasing trend from 1997 onwards. There were 212 accidents involving 67 fatalities in the year 2003.

Figure 7. U.S. Civil Helicopter Accidents: Number of Accidents and Number of Fatalities per Year

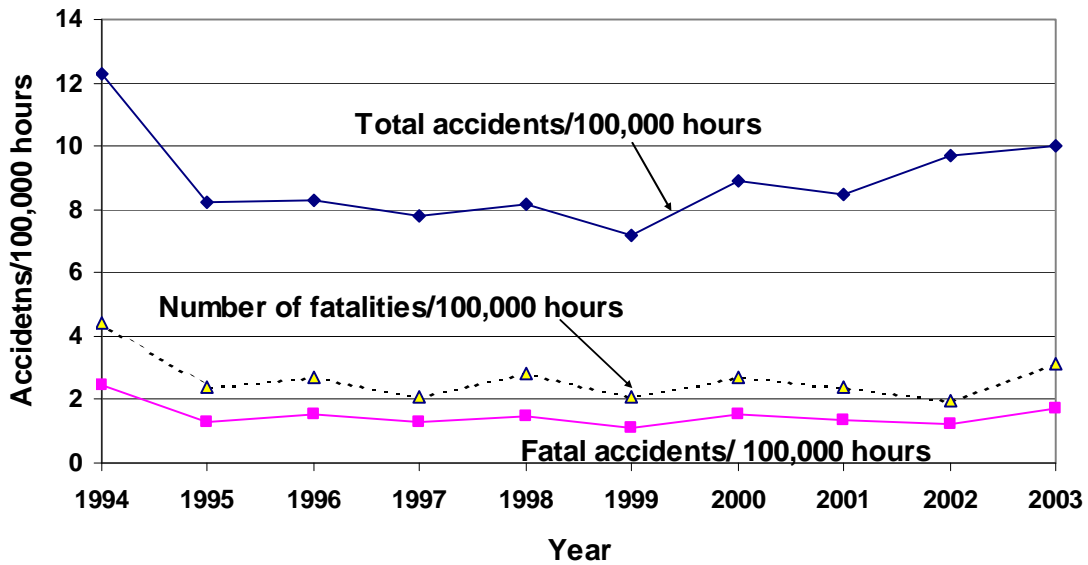
A commonly used safety metric is the number of accidents per 100,000 flight hours (total number of accidents/total flight hours/100,000). Figure 8 shows the rate of the total accidents, total number of fatal accidents, and the number of fatalities per 100,000 flight hours. All these metrics show an increasing trend from about 1999.

Figure 8. U.S. Civil Helicopter Accidents: Trend of Number of Accidents, Number of Fatalities, and Number of Fatal Accidents per 100,000 Flight Hours

The rate of accidents in 2003 was close to ten accidents per 100,000 flight hours. There were 1.74 fatal accidents per 100,000 hours in the year 2003. The corresponding rates for fixed-wing aircraft operated by air carriers under 14 CFR 121 are shown in figure 9. In the year 2003, the number of accidents for fixed-wing of aircraft was slightly above 0.3 accidents per 100,000 flight

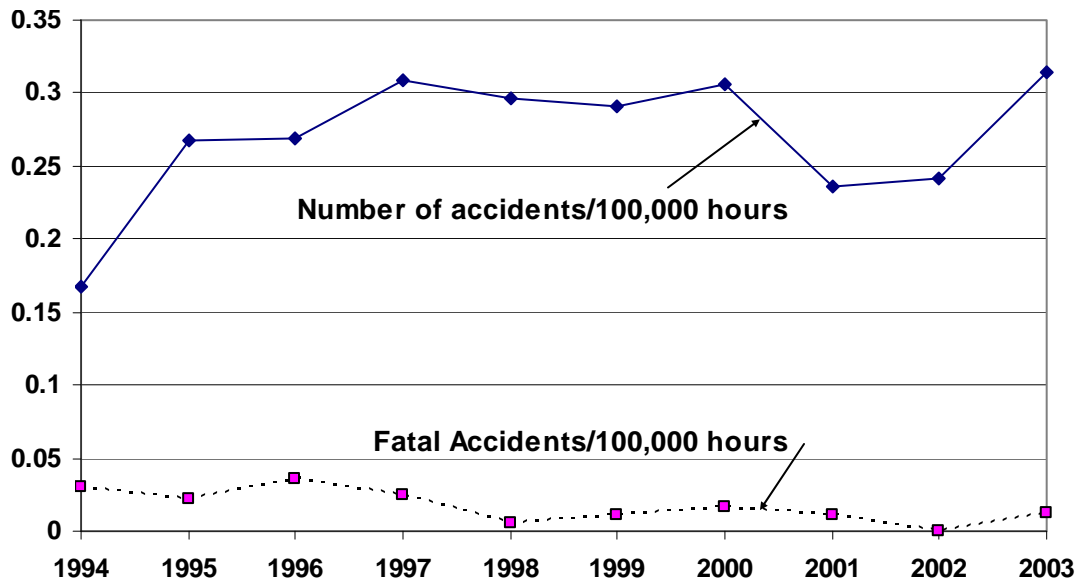
hours. Thus, the rate of accidents per 100,000 hours for fixed-wing aircraft is 3% of the accident rate for helicopters.

Figure 9. Accident Rates, 1994 Through 2003, for U.S. Air Carriers Operating Under 14 CFR 121

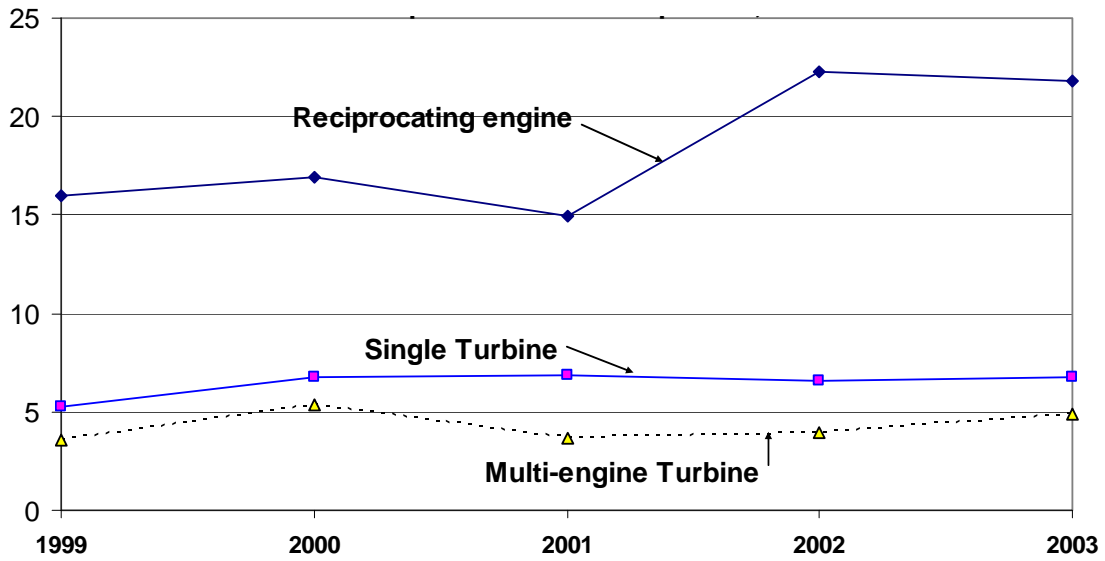
The U.S.-registered civil helicopter fleet consists of helicopters powered by single reciprocating engines, single turbine engines, and multiple turbine engines. Figure 10 shows the accident rate (per 100,000 hours) for each of these types of helicopters. There has been a sharp increase in the number of accidents involving single reciprocating engine helicopters. The multiengine helicopters have been involved in the lowest number of accidents per 100,000 hours; this rate is also showing an increasing trend, about five accidents/100,000 hours in 2003.

Figure 10. U.S. Civil Helicopter Accident Rates by Engine Type

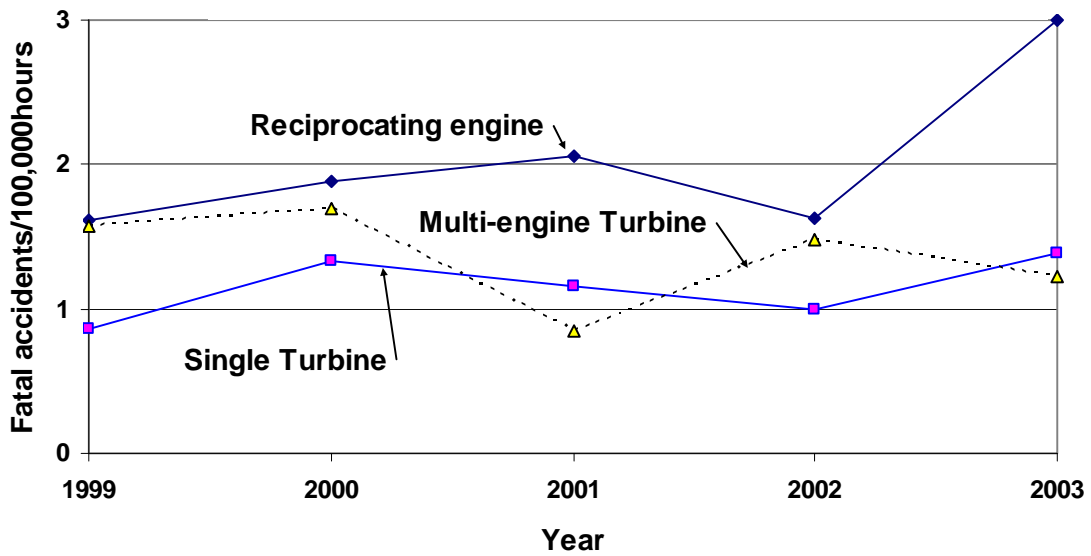
Figures 11 and 12 show the number of fatal accidents and the number of fatalities per 100,000 hours for the three types of helicopters. Helicopters with reciprocating engines appear more susceptible to accidents involving fatalities per 100,000 hours.

Figure 11. U.S. Civil Helicopter Accidents: Fatal Accidents/100,000 Flight Hours by Engine Type

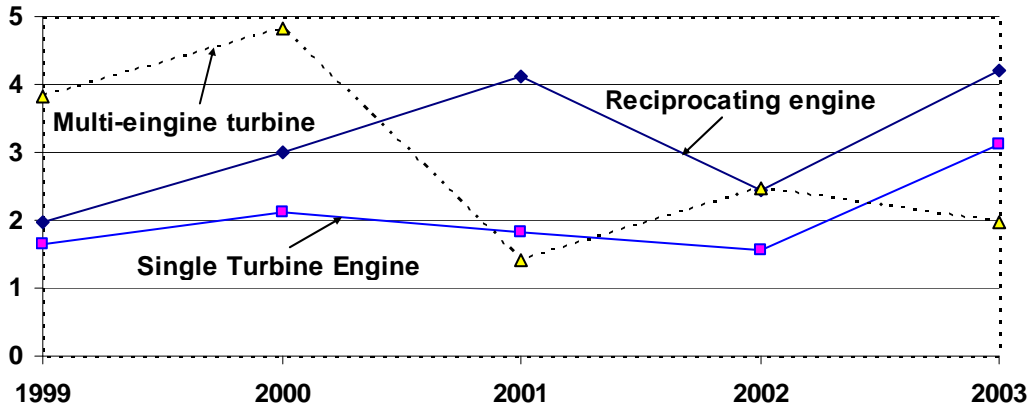
Figure 12. U.S. Civil Helicopter Accidents: Fatalities/100,000 Flight Hours by Engine Type

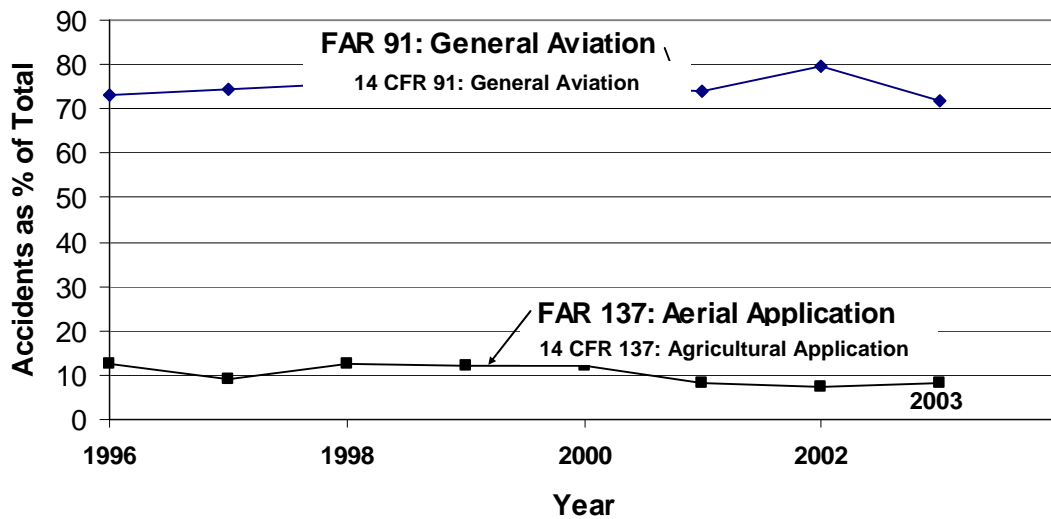
Figure 13 shows the accidents in which helicopters conducting 14 CFR Part 91 (general aviation) and 14 CFR Part 137 (agricultural application) operations were involved. Helicopters conducting general aviation operations were involved in 70% to 80% of all civil helicopter accidents. Helicopters involved in agricultural application operations accounted for about 10% of all the accidents.

Figure 13. U.S. Civil Helicopter Accidents by Type of Operation

As a comparison, the percentage breakdown of civil helicopter accidents was general aviation: between 70% and 80% and agricultural: 10% (figure 13).

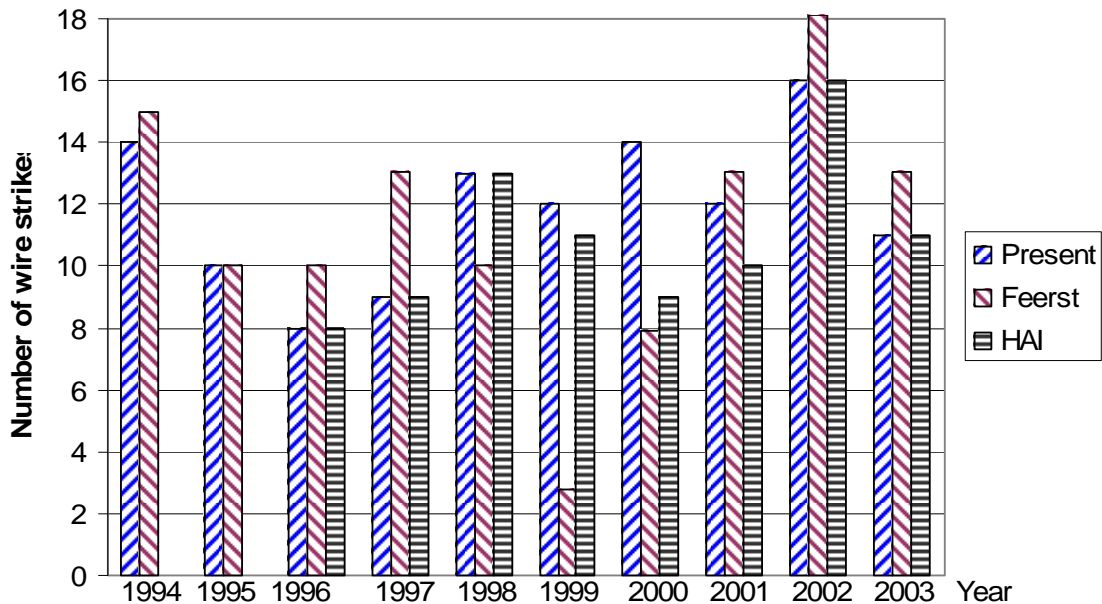
As mentioned in section 3.2.1, a number of key words need to be used when querying the NTSB database to compile a report on a particular type of accident. Because researchers do not use the same keywords to query the database, the result is different statistics being quoted by different researchers. For example, figure 14 shows a comparison of accident data generated in the present study with similar data from Freest [11] and HAI [12]. Even though there is a difference in the number of accidents reported per year, there is fair agreement between the three sets of data.

Figure 14. Comparison of Yearly U.S. Civil Helicopter Wire Strike Accidents Obtained in Three Different Studies

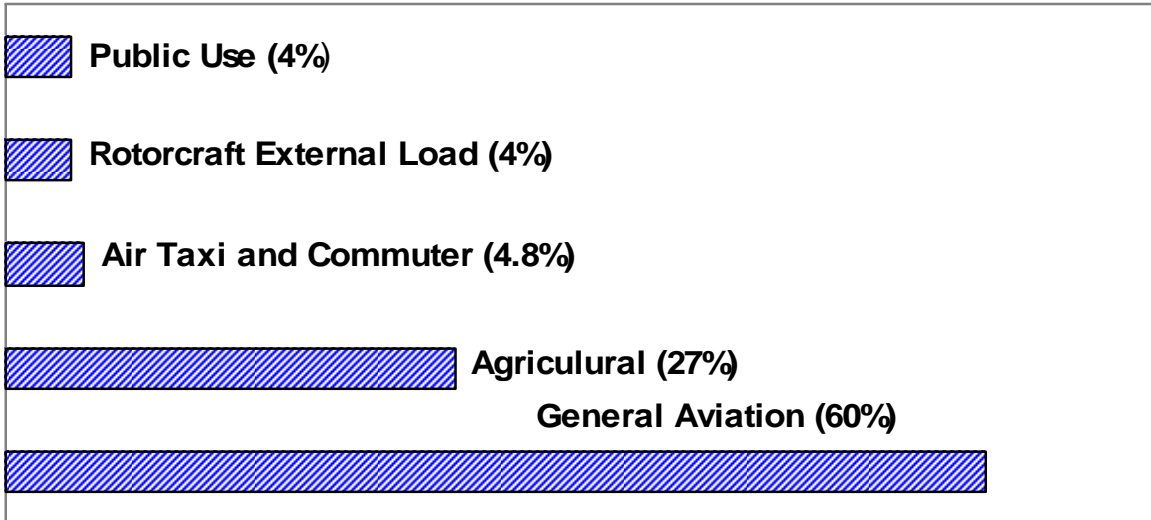
Table 7 provides a comparison of wire strike accidents by the type of operation for the two periods: 1970-1979 and 1994-2003. In 1970-1979, general aviation operations accounted for 42% of the wire strikes, while agricultural operations accounted for about 48% of all wire strike accidents. Figure 15 shows the wire strike accidents by type of operation for 1994-2003. Figure 16 shows the yearly distribution of wire strike accidents as a percentage of total in general aviation and agricultural application operations. The wire strike percentage in general aviation operations has increased since about 1999.

Figure 15. Civil Helicopter Wire Strike Accidents by Type of Operation for 1994-2003

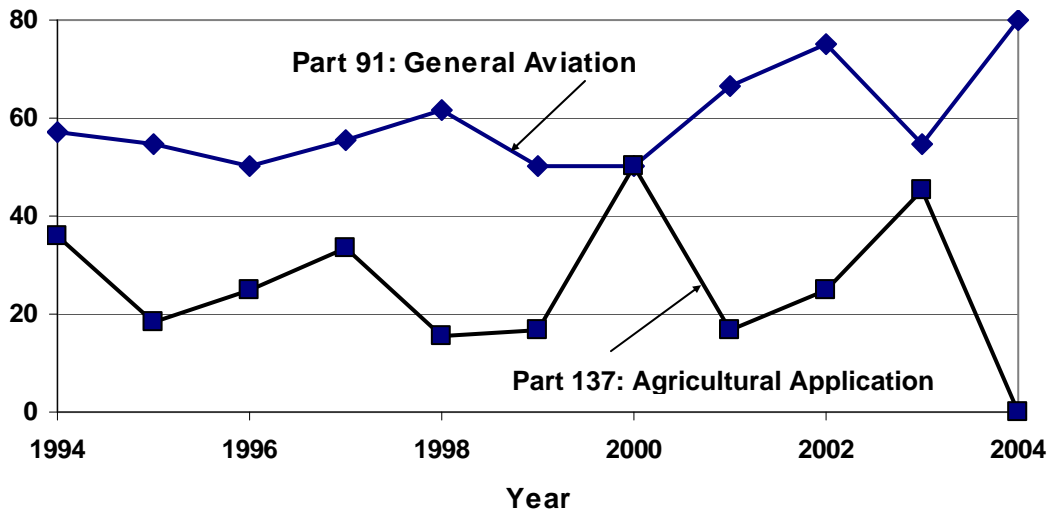
Figure 16. U.S. Civil Helicopter Wire Strike Accidents by Type of Operation

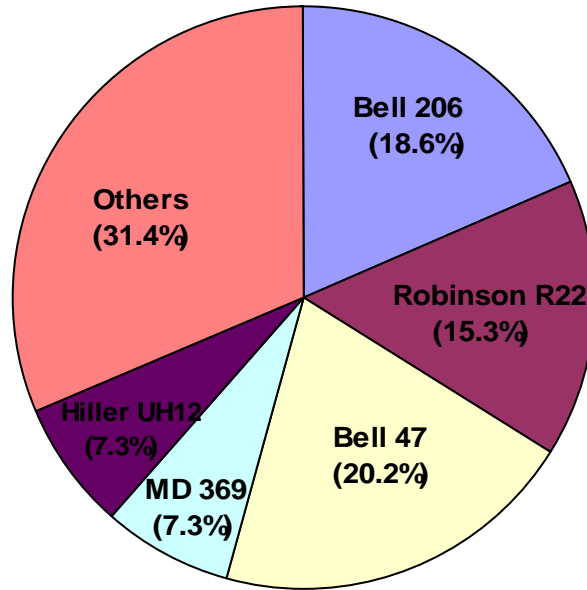
Figure 17 shows the percentage of wire strike accidents for each of the helicopter types that have been involved. The Bell 47 and its variants account for about 20% of all the wire strike accidents while the Bell 206 and its variants come close with 18.6%. The Robinson R22 (including three R44 models) accounts for another 15.3% of the accidents. Other helicopter models such as the Eurocopter AS-350 and Enstrom F280 accounted for about 31% of the wire strike accidents. Figures 18, 19, and 20 show the number of wire strike accidents for the years 1994 to 2004 for the Bell 206, Bell 47, and Robinson R22 models. Of the helicopters involved in wire strike accidents (table 8), FAA-approved wire strike protection kits (wire cutters) are available for the following models: Bell 205, 212, and 407, Eurocopter AS-350 and BK-117, and McDonnell Douglas (MD) helicopters MD-900. As shown in table 8, these helicopter models account for 32 of the 124 helicopters (25.8%) involved in wire strike accidents. FAA-approved wire cutters were not available for the other helicopters mentioned above. Thus, nearly 74% of the helicopters involved in the wire strikes could not have been fitted with wire cutters.

Figure 17. Helicopter Wire Strike Accidents by Model

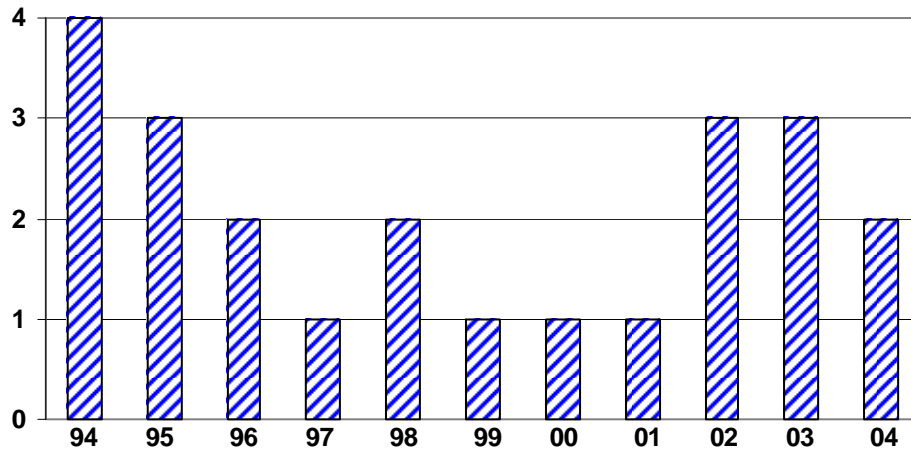
Figure 18. Wire Strike Accidents Involving Bell 206

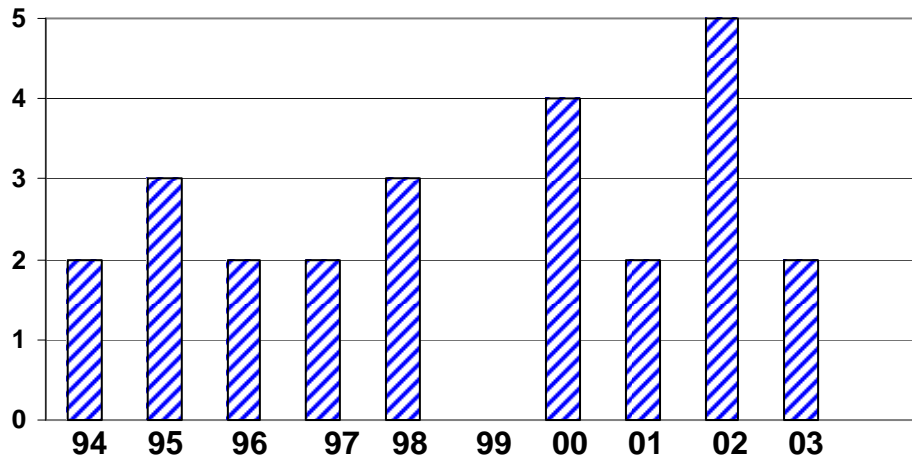
Figure 19. Wire Strike Accidents Involving Bell 47

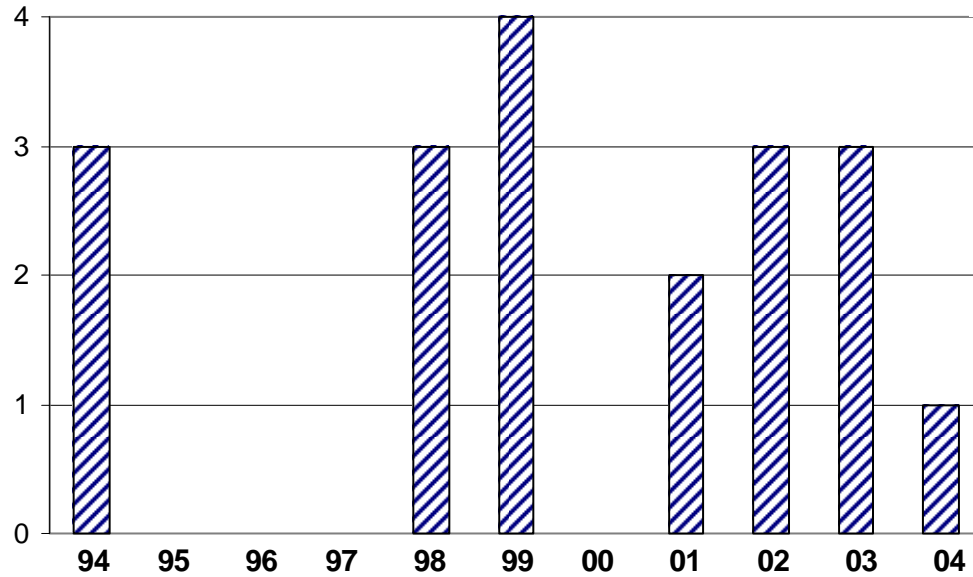
Figure 20. Wire Strike Accidents Involving Robinson R22

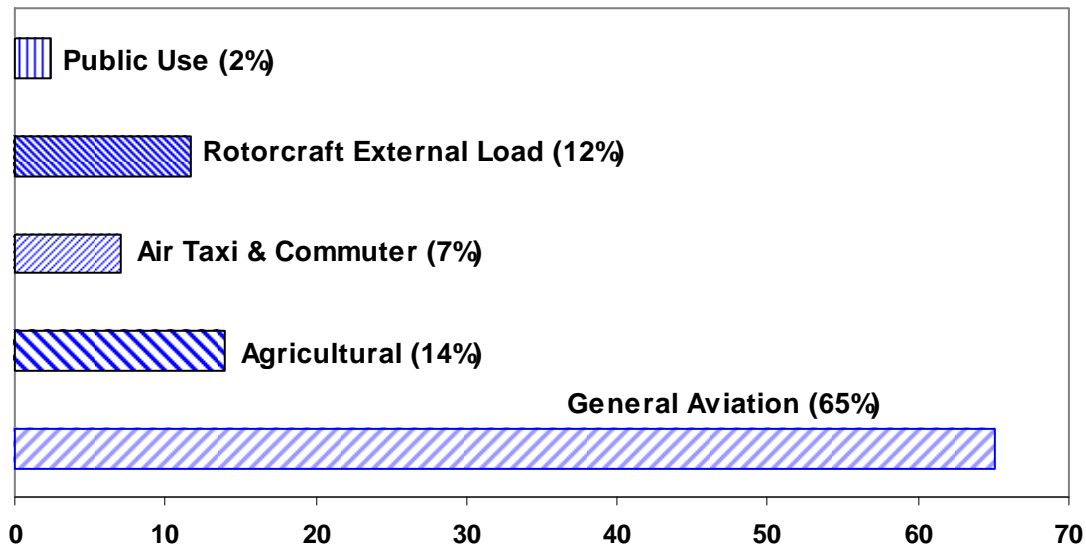
Figure 21. U.S. Civil Helicopter Fatal Accidents by Operation (1994-2003)

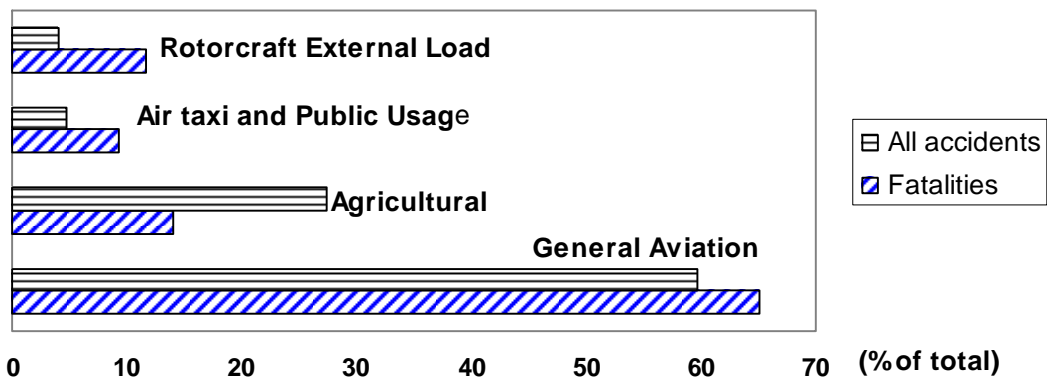
Figure 22 shows a comparison of the proportion of all wire strike accidents (as percentage of the total) with the fatalities in each type of operation. Operations under 14 CFR Part 91 general aviation account for about 65% of wire strike accidents and for about 60% of the fatalities. Agricultural operations account for about 27% of wire strike accidents and about 14% of fatalities in wire strikes (14 CFR Part 137).

Figure 22. Comparison of Accidents and Fatalities by Type of Operation (1994-2003)

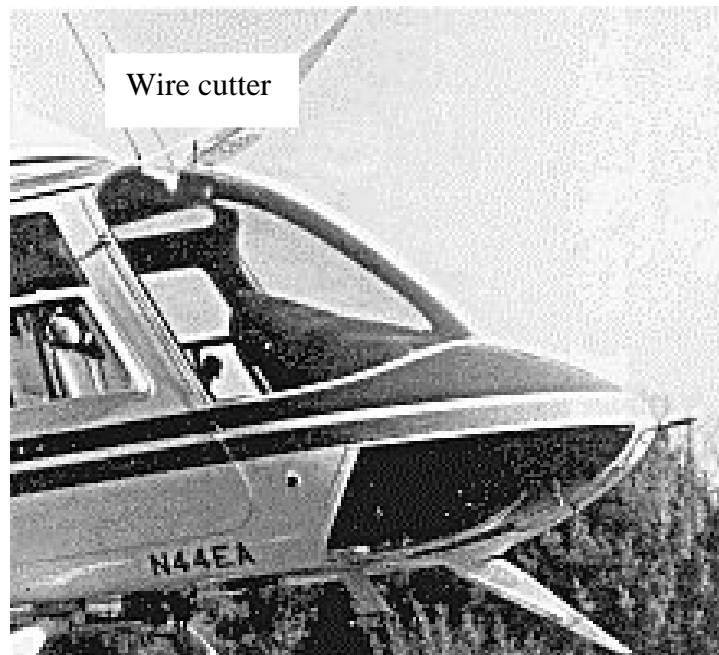
Wire impacts have serious consequences to helicopters. For example, a power transmission cable can slice through the windshield if the helicopter impacts the cable at sufficient forward speed. One system that can provide a degree of protection to the helicopter in frontal impacts is the WSPS, manufactured by Bristol Aerospace Limited. A typical installation consists of a roof-mounted cutter and one or more cutters mounted on the fuselage of the helicopter. A deflector running vertically along the middle of the windshield guides the cables into the cutters. Figure 23 shows the system installed on a Bell 206.

Figure 23. The WSPS Installed on a Bell 206 [13]

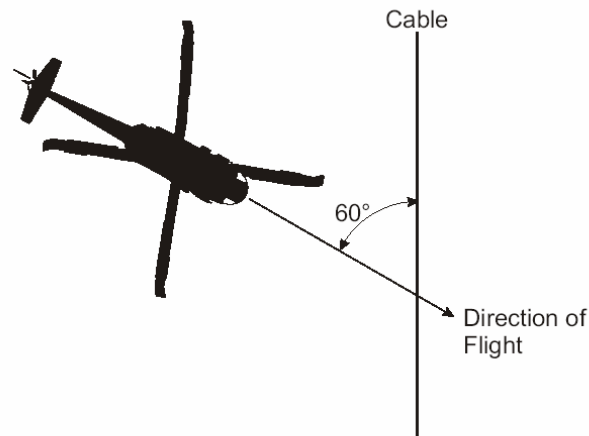
Angle Strike Design Parameters

For the cutters to be effective, the helicopter must be flying at speeds greater than 30 knots [14]. The manufacturer states that if a helicopter with a WSPS impacts a wire at an angle less than  $60^\circ$  to the wire, the WSPS may not cut the wire (figure 24). In addition, the maximum pitch angle at which the WSPS should strike the wire and still be effective is  $\pm 5^\circ$ . The system is designed to cut a 3/8-inch steel cable with a breaking strength of 12,000 lb [14].

Figure 24. Maximum Wire Strike Angle [15]

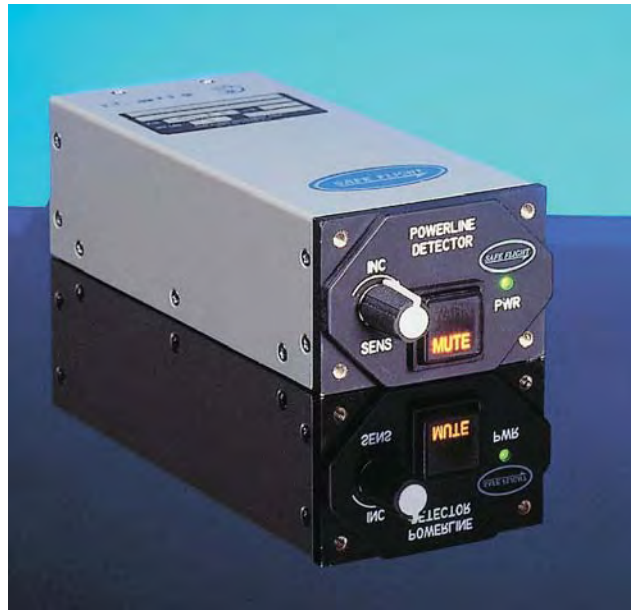
The Powerline Detector, manufactured by Safe Flight Instrumentation Corp., is a system that senses the electromagnetic fields surrounding power lines and uses this information to alert the pilot to the proximity of wires. The system consists of an electronics unit mounted in the cockpit (figure 25) and a whip antenna mounted on the fuselage. The antenna can be placed on the nose, roof, or tail boom of the aircraft. The electronic unit measures 1.66" x 2.42" x 5.51", and the total system weight is approximately 3 pounds [17].

Figure 25. Powerline Detector Electronics Control [17]

If a power line is detected in the flight path, the system gives the pilot an audible warning starting from a distance of 1800 feet from the hazard. The warning sound increases in frequency as the power line gets closer. If the pilot continues to approach the power line, a red warning light illuminates in the cockpit. The system can be temporarily muted when flying in an area where there are a number of power lines [17].

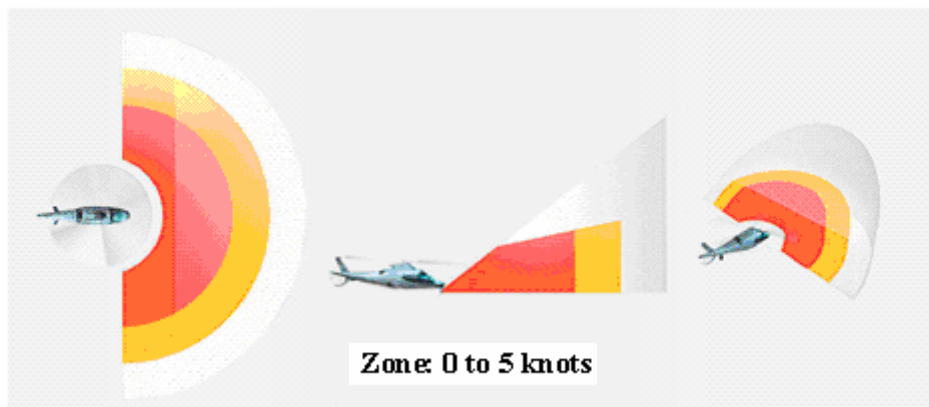
Figure 26. Zones of Scan, OASys (Hover to 5 knots)

The OASys radar (Amphitech Systems) uses a radar mounted on the nose of the helicopter to transmit a 35-GHz radio frequency for detecting obstacles in the flight path. The radar constantly searches for obstacles in its field of view. At a given instant of time, the system uses data from the aircraft's GPS receiver to calculate the aircraft's flight path for the succeeding 19 seconds. Three zones of increasing potential risk are then designated by the system. If the obstacle is located in any of these three zones, the pilot is given a level of alert that depends on the proximity and zone of the obstacle and is notified by a small display in the cockpit that illuminates in accordance with the distance and direction to the obstacle. OASys also adapts to the requirements of the flight. For instance, during takeoff, the system scans a wide angle around the helicopter, but only a short distance in front of it. However, when the aircraft is cruising at high speeds, the scan narrows, but looks far ahead in the flight path [10]. These zones are shown in figures 26 and 27.

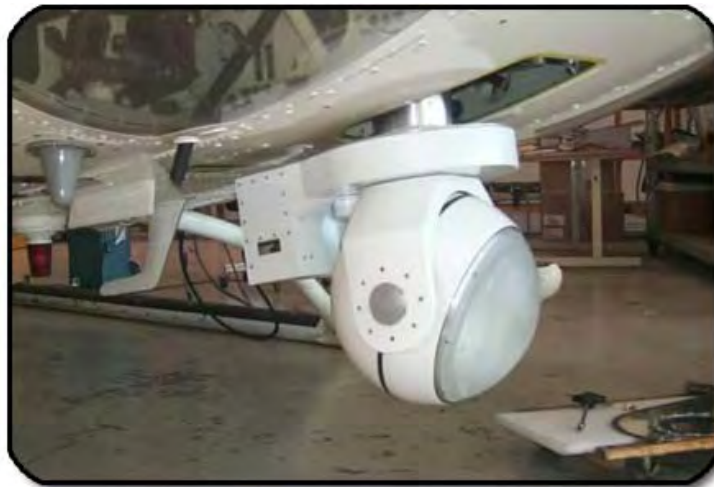
Figure 28. The OASys Scan Head [19]

The OASys radar has a maximum range of 1600 meters, an optimal range of 800 meters, and a minimum range of 2 meters. This system is also effective in rain and fog. The physical unit consists of an electronics box mounted inside the helicopter and a sensor mounted on the nose of

the helicopter (figure 28). The sensor dimensions are 15.48" x 16.78" x 22.44", and the total weight is approximately 54 pounds.

Though the mounted sensor may be large, it produces little added drag on the helicopter (see figure 28). The manufacturer, Amphitech, estimates that there will be a loss of 1 knot when cruising at 140 knots. OASys does not detect objects behind or directly above the aircraft. Thus, the system will not warn the pilot of wires near the tail rotor while hovering or taking off.

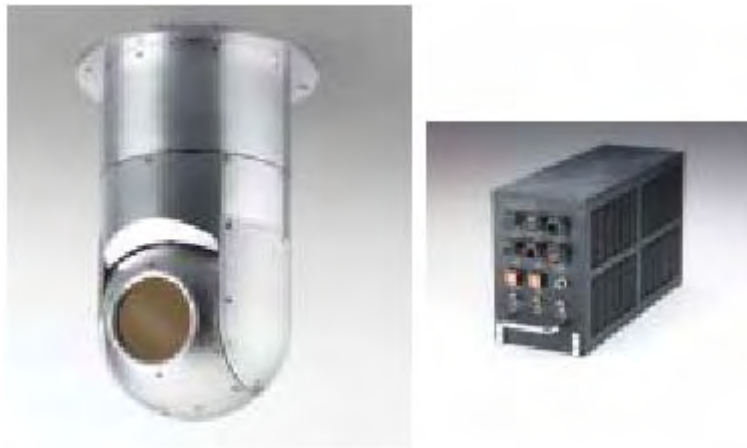
Figure 29. The LOAS Scan Head and Electronics [20]

The system has the capability of being pointed in the direction desired by the pilot [21]. The range of the system varies from 2 meters (minimum) to 2 kilometers (maximum). The scan head has a horizontal field of view of 180° and a vertical field of view of +30° to -90° [20]. The scan head and electronics box are shown in figure 29.

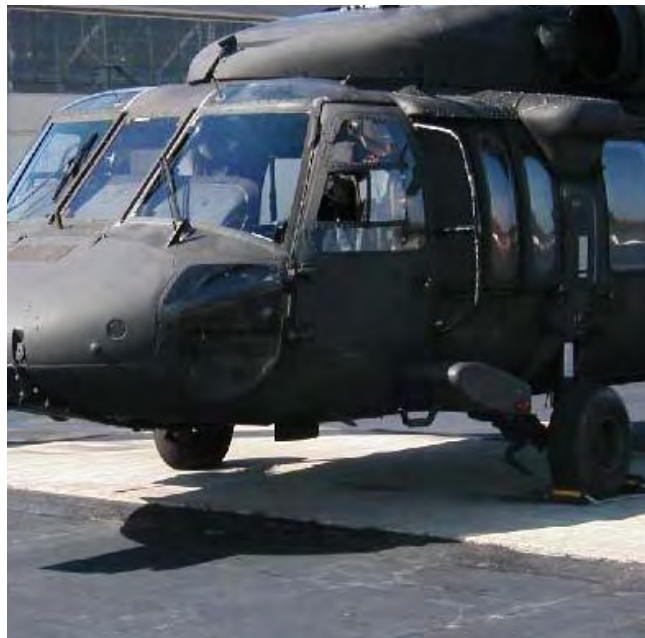
Figure 30. HELLAS Installed on UH-60 Helicopter

rotorcraft too close to the obstacle [22]. The system is connected to the helicopter by a standard interface, which requires 28 Vdc [23]. Figure 30 shows the optical display box installed on the fuselage.

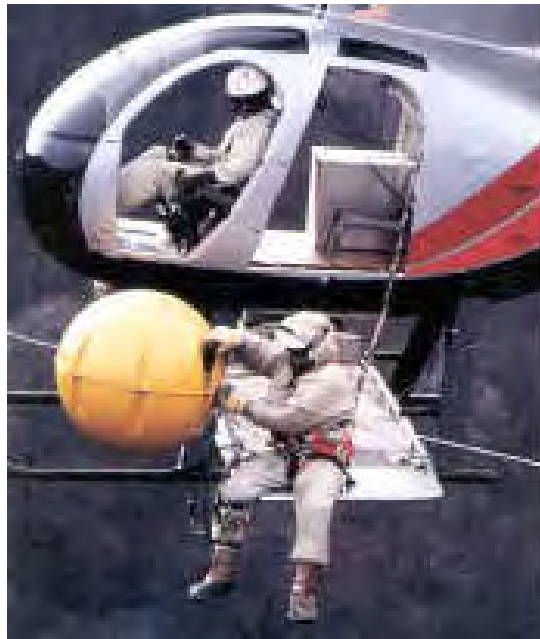
Figure 31. SpanGUARD Installation [29]

SpanGUARD Helimark Aerial markers, manufactured by P&R Technologies, are colored spherical balls that are attached to wires and power lines to make them more visually prominent to aircraft pilots. The spheres are available in orange, yellow, and white, and in varying diameters. The markers use a wire rod that wraps around the line to grip the wire. The construction includes the rods connected to the outside of the marker and lock nuts for easier live line installation. These markers use a clam shell design so that they can be installed easily by hand from a helicopter or installed before the power lines are strung up. Aerial markers should last many years. They are designed to minimize color degradation caused by the sun. P&R Technologies does not estimate an official life span for the markers, but cites several counties in the U.S. where the markers have been in place for over 20 years [28]. Figure 31 shows a marker being installed from a helicopter. The weight and cost of some spherical markers are given in table 13.
